Essex Highways

Boxted Bridge Report

Date: 19/05/2021

Boxted Bridge Assessment Report

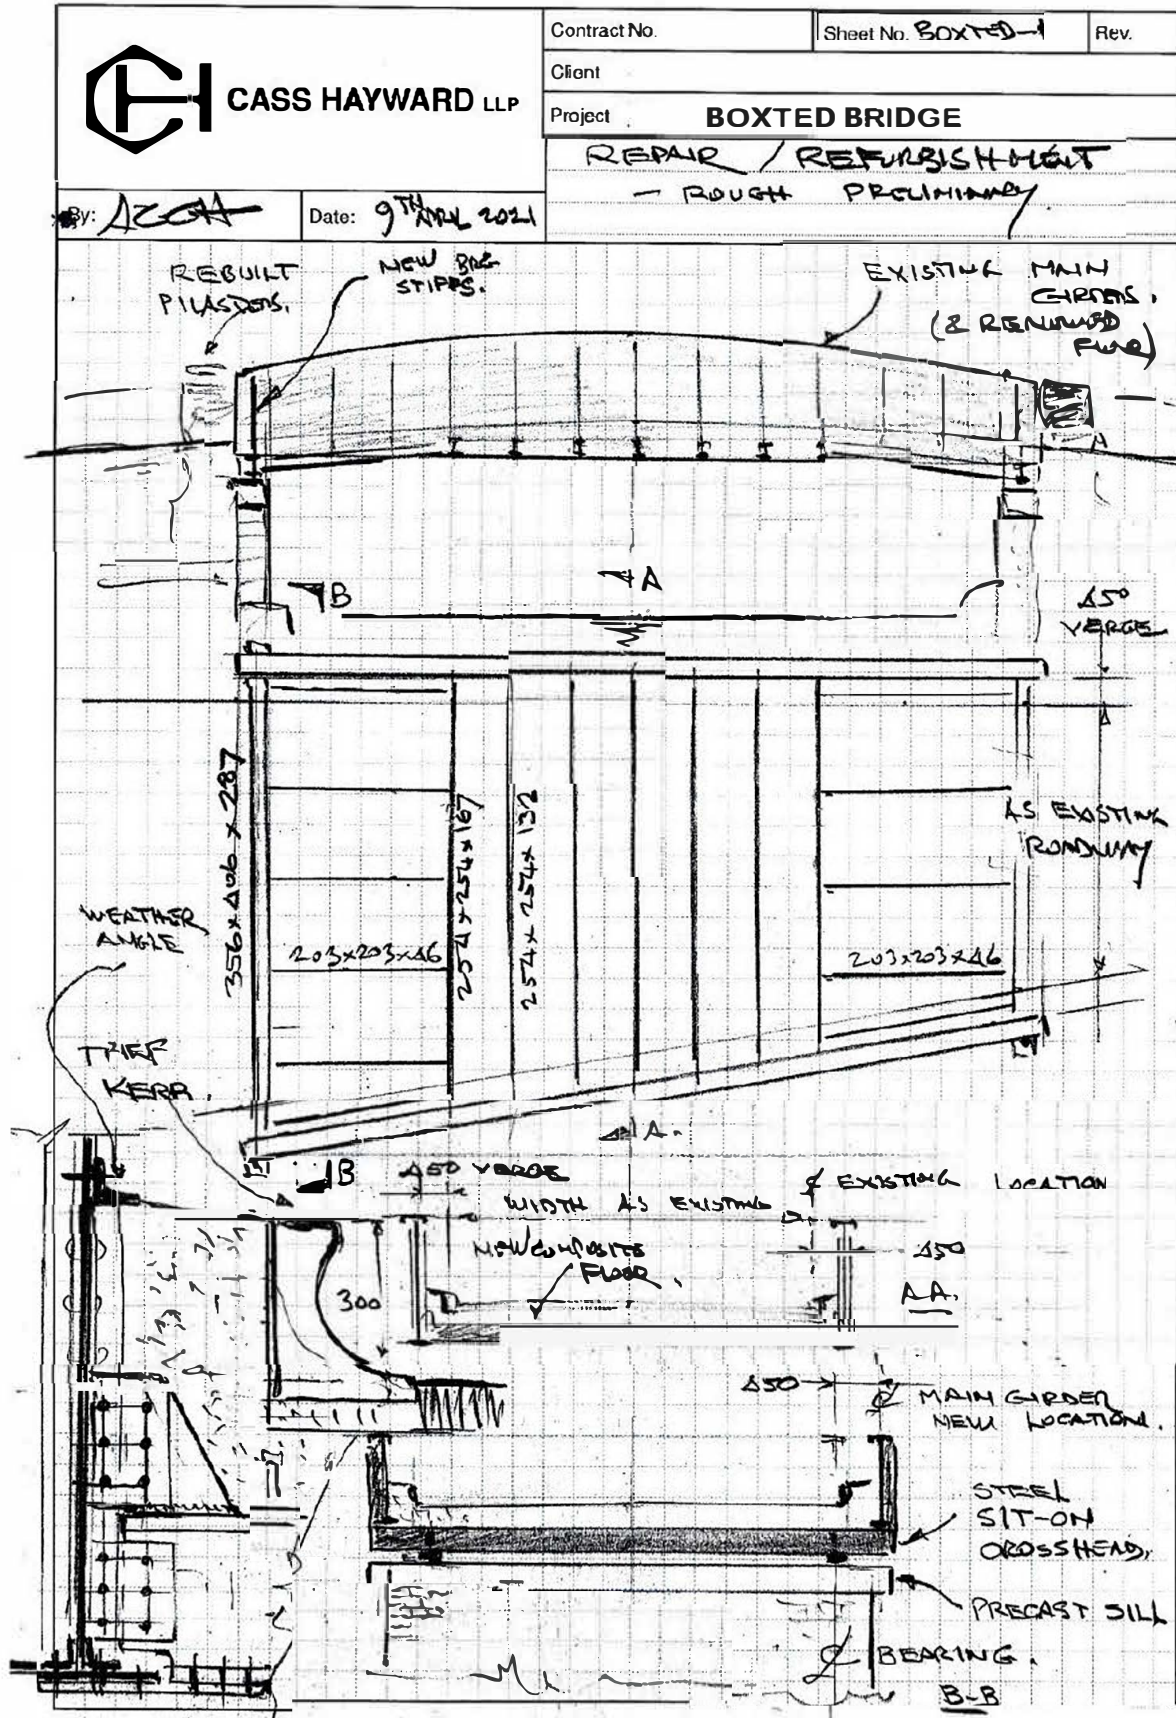
Sketch of refurbishment option

On Botted bridge it is clear that the deck is severely decayed and that it's form of construction (presence of buckle plates and concrete against items requiring repair) makes local repair impracticable and uneconomic. There is also a risk that there is severe decay in parts that are covered, and cannot be inspected.

For illustrative purposes we have developed a refurbishment option involving retention of the main girders only – subject to capacity checks outlined above. The option is shown in sketch BOXTED -1 (appendix A), and described in principle below:

- 4.1. Sketch BOXTED -1 shows reuse of the existing main girders, but with the floor replaced. This assumes that the girders are found on blast cleaning to be in repairable condition, and subject to capacity check (non-linear buckling analysis) requiring measurement of straightness and twist. The present splice plates to the flanges would be replaced with others of increased capacity. Local repairs to any decayed areas would be required.

- 4.2. The bridge floor would be replaced in a similar layout to the existing using composite UC sections. Intermediate U-frame stiffness would be achieved by rigid TCB connections (possibly to new stiffeners) within the raised verges.

- 4.3. The work would involve stabilisation of each main girder followed by removal of the existing deck. This itself would need careful consideration of method including protection to the waterway etc. Normal demolition of the floor concrete would be hindered by the buckle plated soffit.

- 4.5. The girders would be supported by steel "sit-on" trimmers rigidly connected to new bearing stiffeners on the refurbished girders. This would provide rigid end U-frames to stabilise against buckling and provide impact resistance. The trimmers would have inboard disc bearings beneath to provide load distribution via precast sills onto the existing abutments.

- 4.6. On return to site the main girders would be repositioned outwards on the sit-on trimmers to provide verges say 450mm wide with Trief kerbs 300mm high to protect against accidental collision with the girders. The existing pilasters would be rebuilt in front. Appearance of the bridge in elevation and from the road would be largely unchanged.
