Principal Inspection Report

Report Sections

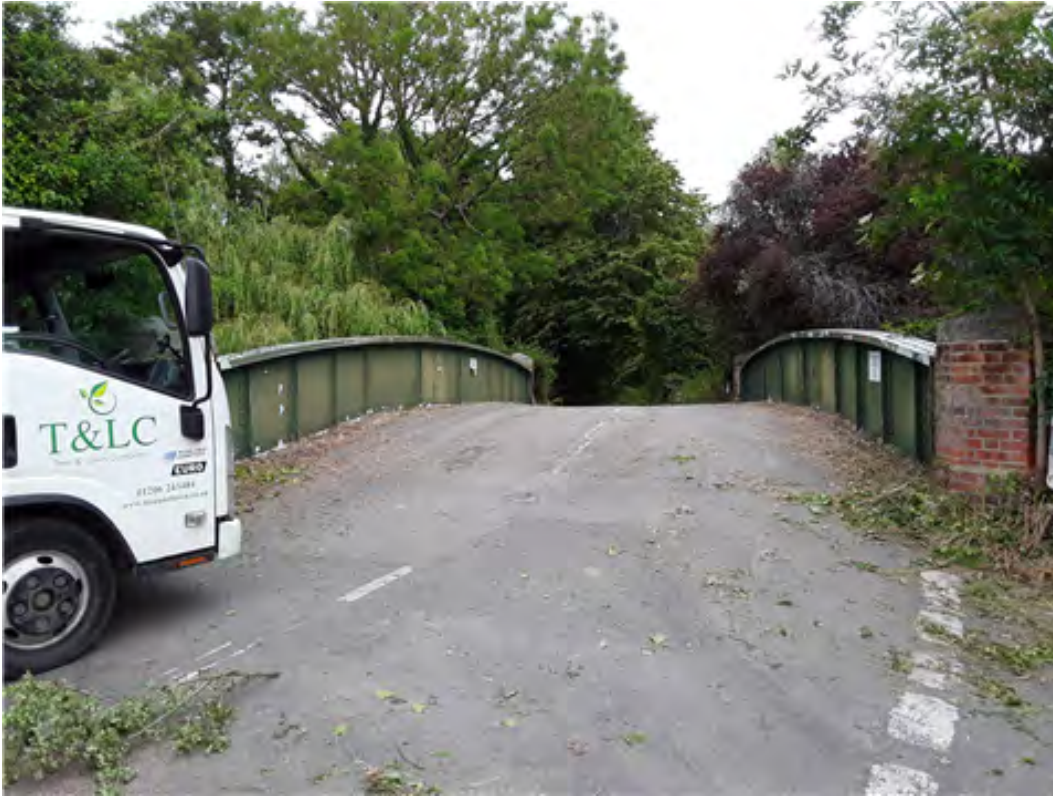
South Topside (looking north)
South Topside (looking north)

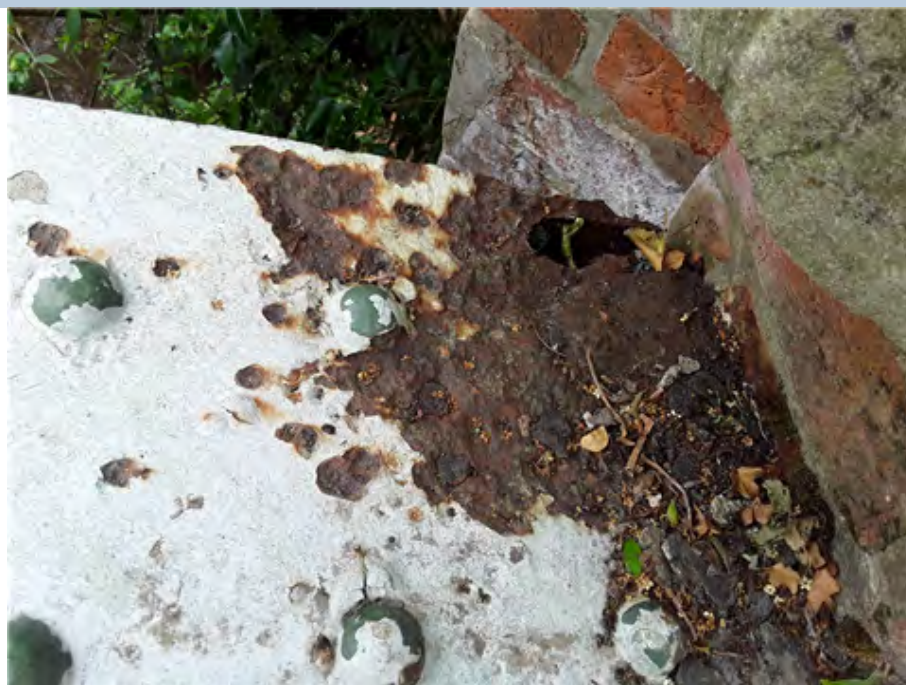
East Girder Top Flange (south end)
 Severe corrosion leading to section loss.

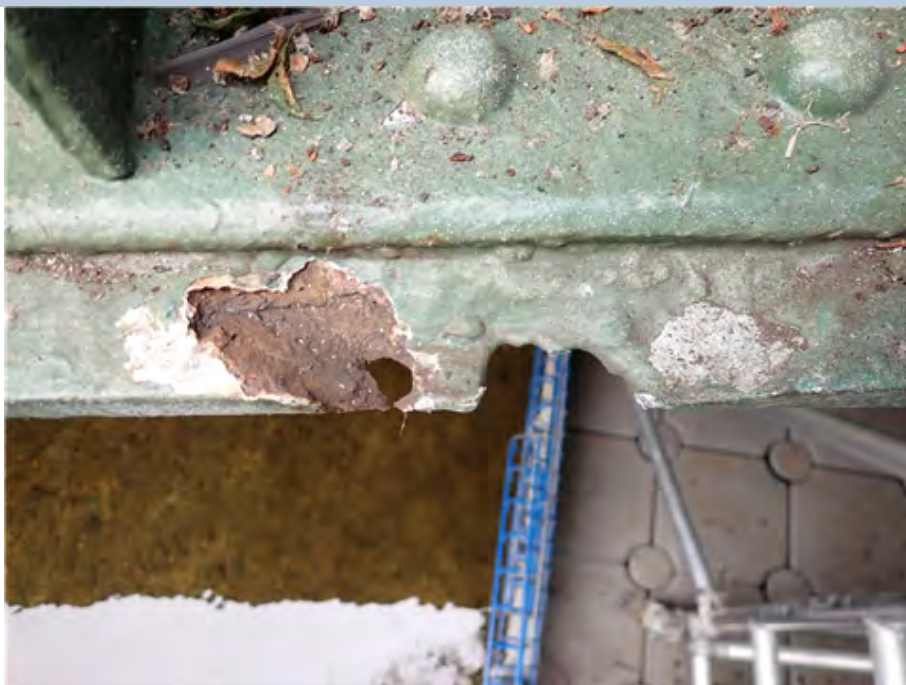
External East Girder Bottom Flange (north end)

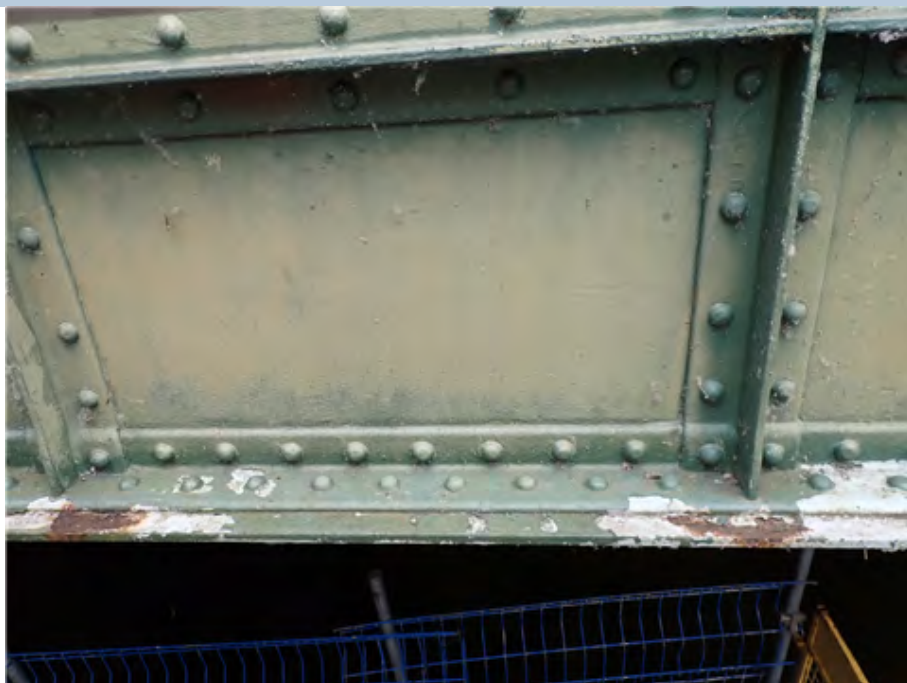
West External Edge Girder Bottom Flange

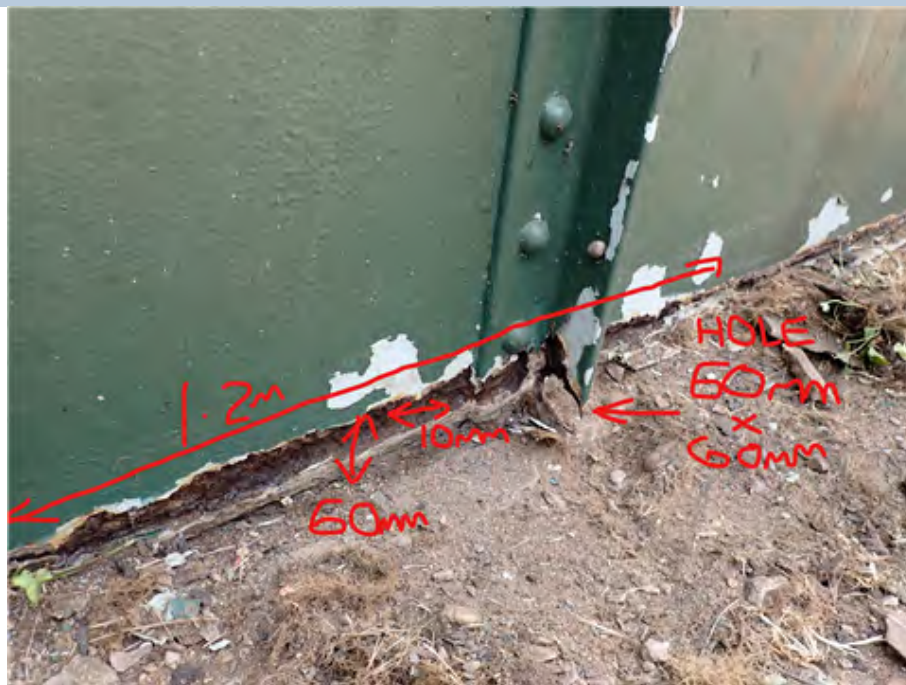
Internal Web Face of East Girder Web and T Stiffener (midspan)

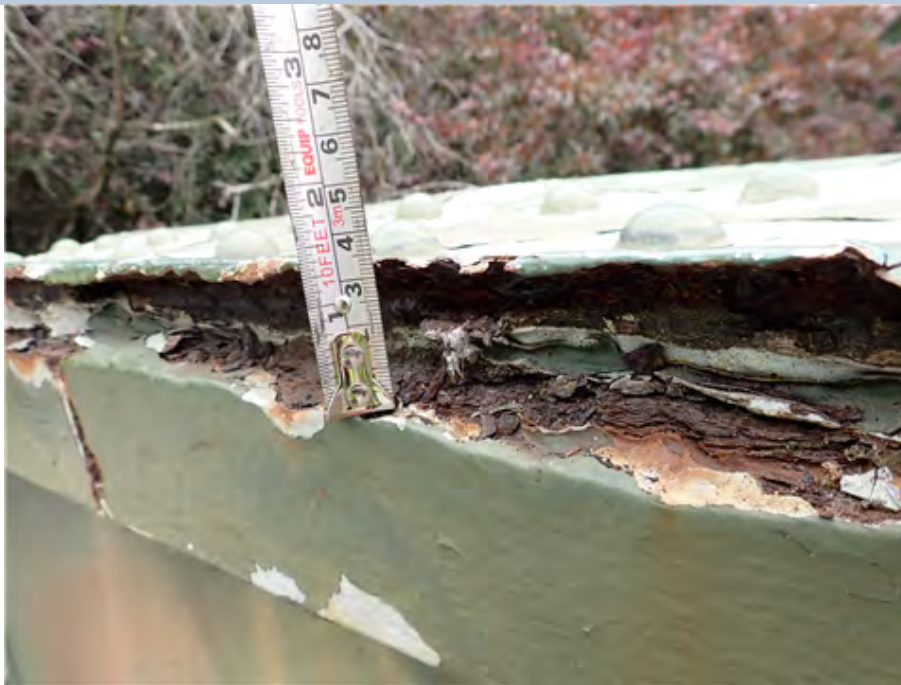
East Edge Girder Riveted Splice Plate
 Severe corrosion leading to deflection of up to 35mm.

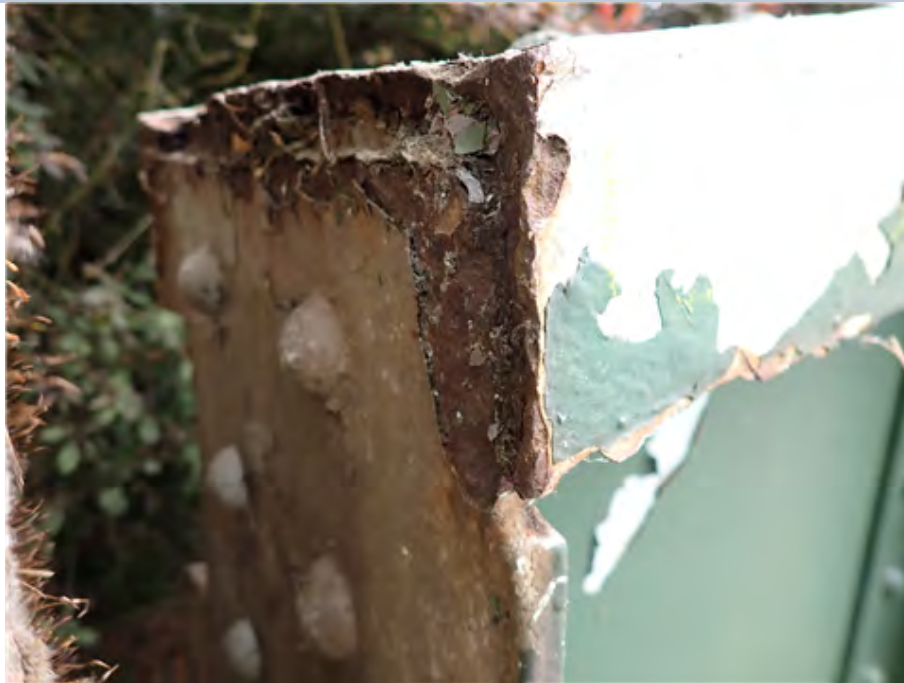
East Edge Girder Top Flange (north side)

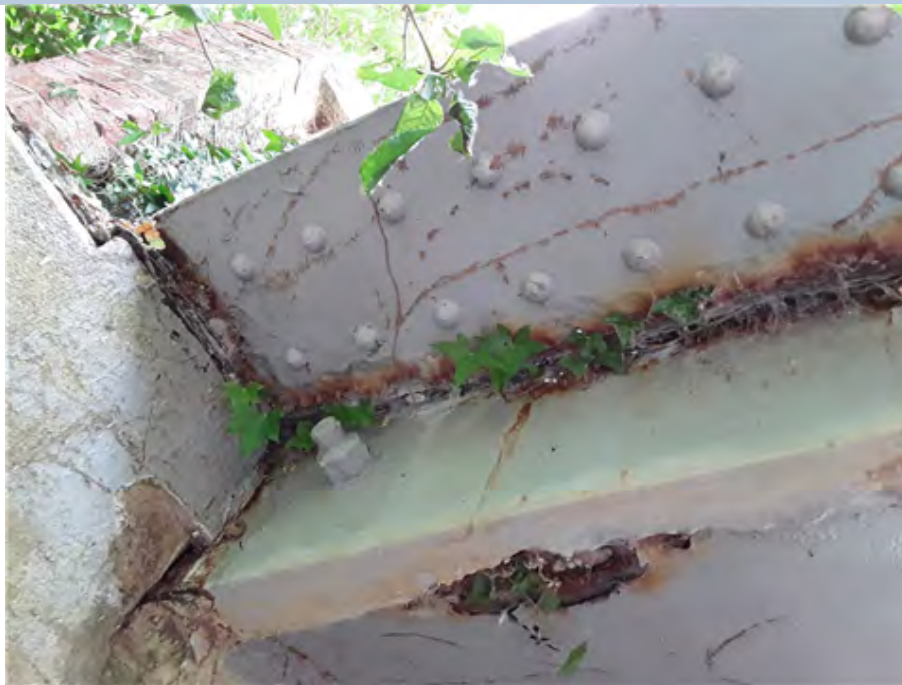
East Edge Girder Bottom Flange (south side)

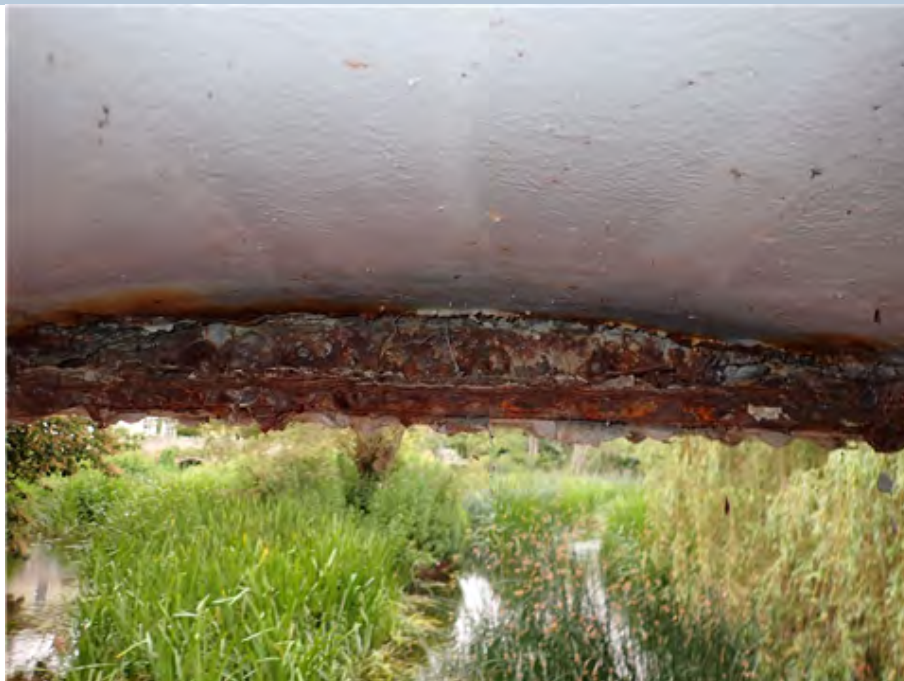
West Edge Girder Bottom Flange and Inner Web (midspan)

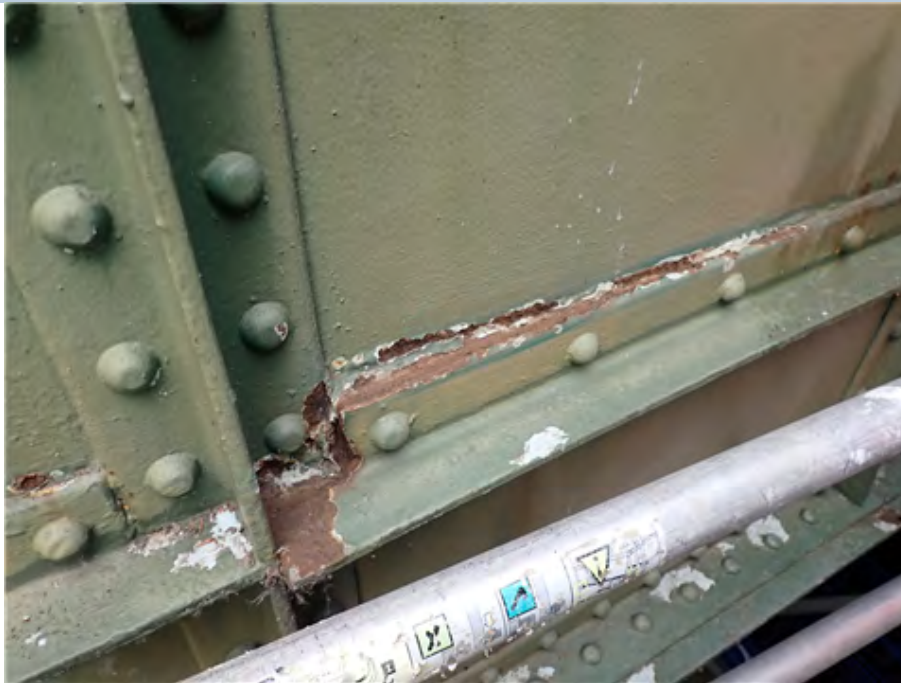
East External Edge Girder (south side)
 Corrosion to the edge girder web and rivet plates of the T stiffeners.

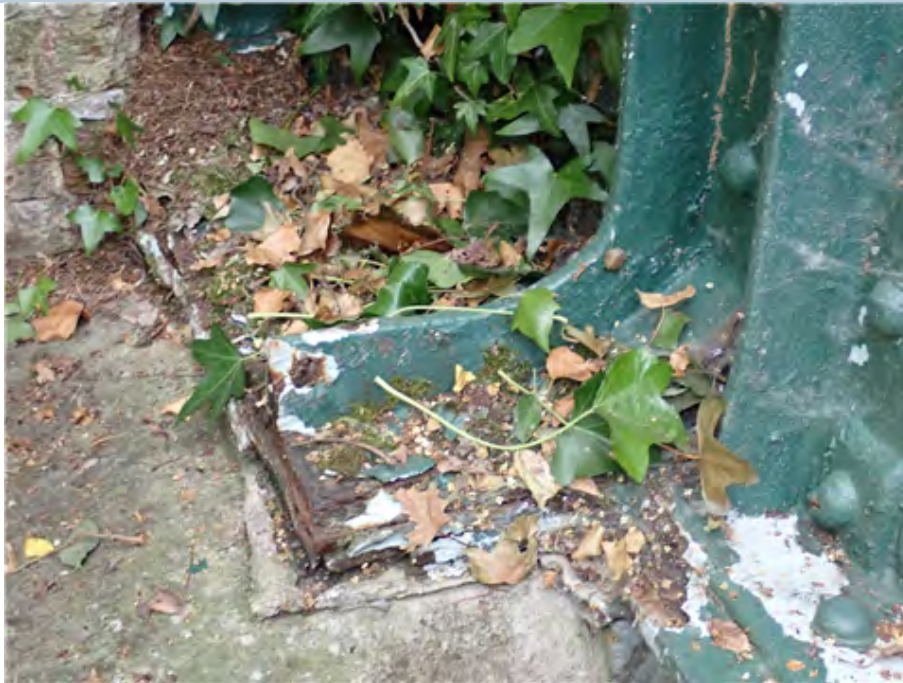
South East Bearing Plate
 Corrosion to bearing plate.

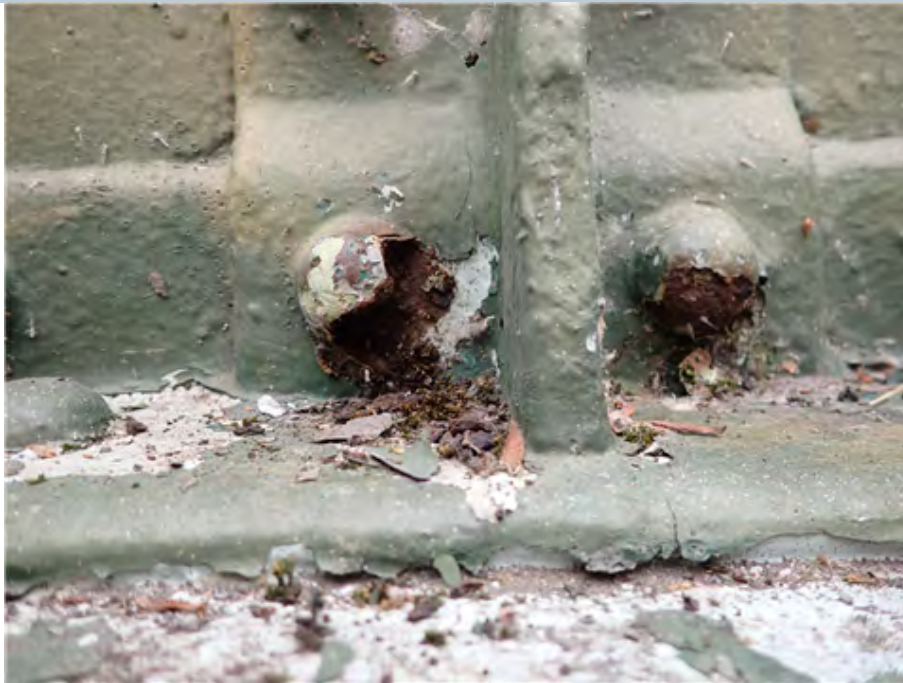
East Edge Girder Stiffener Rivets (East Face) (south end)
 Corroded rivet heads.

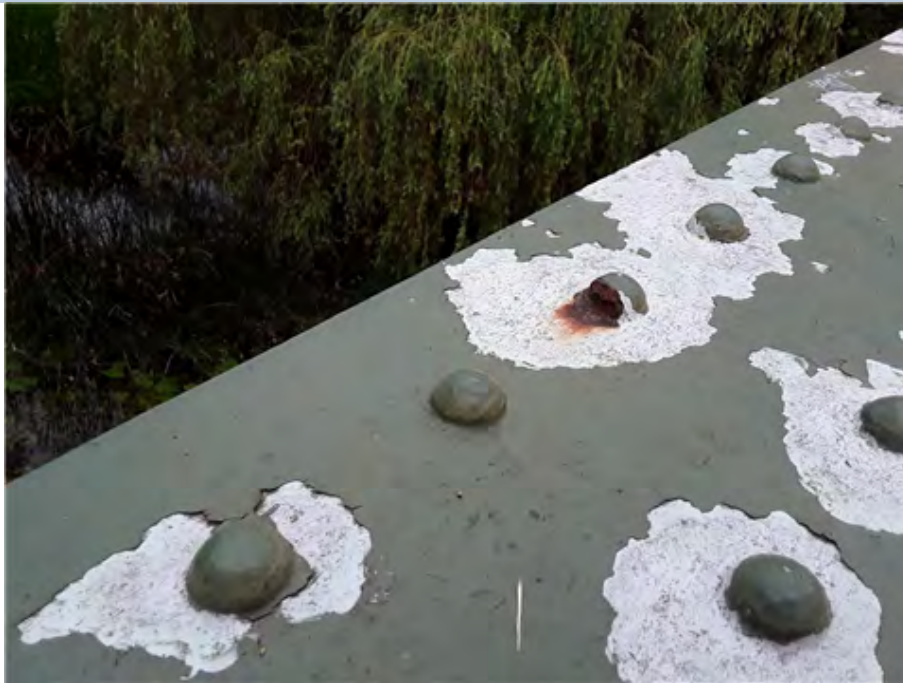
West Edge Girder Top Flange (south end)
 Rivet corroding away with protective paint loss to girder.

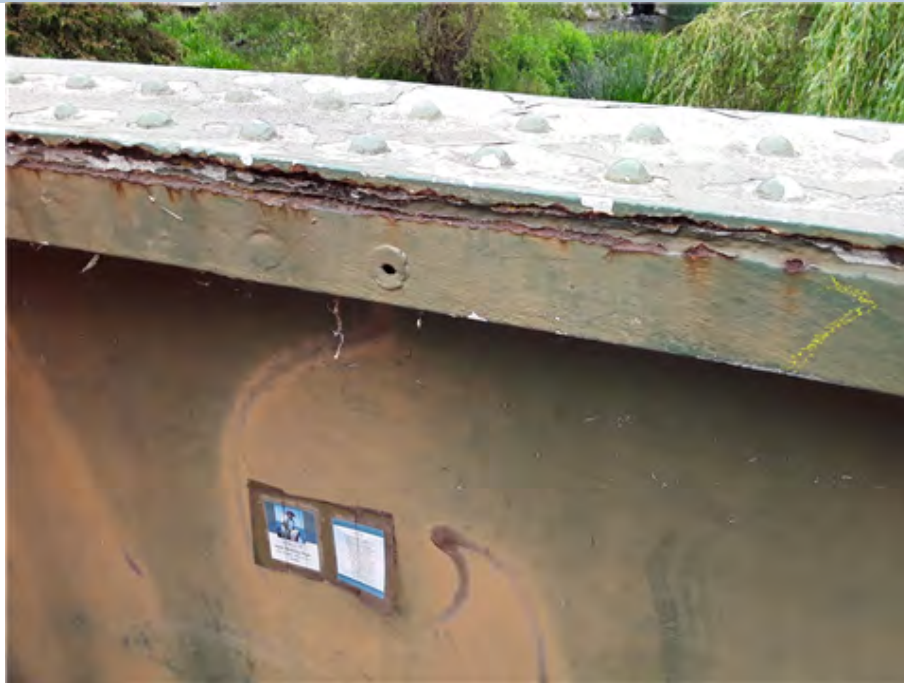
Western Girder (East Face)
 Missing rivet.

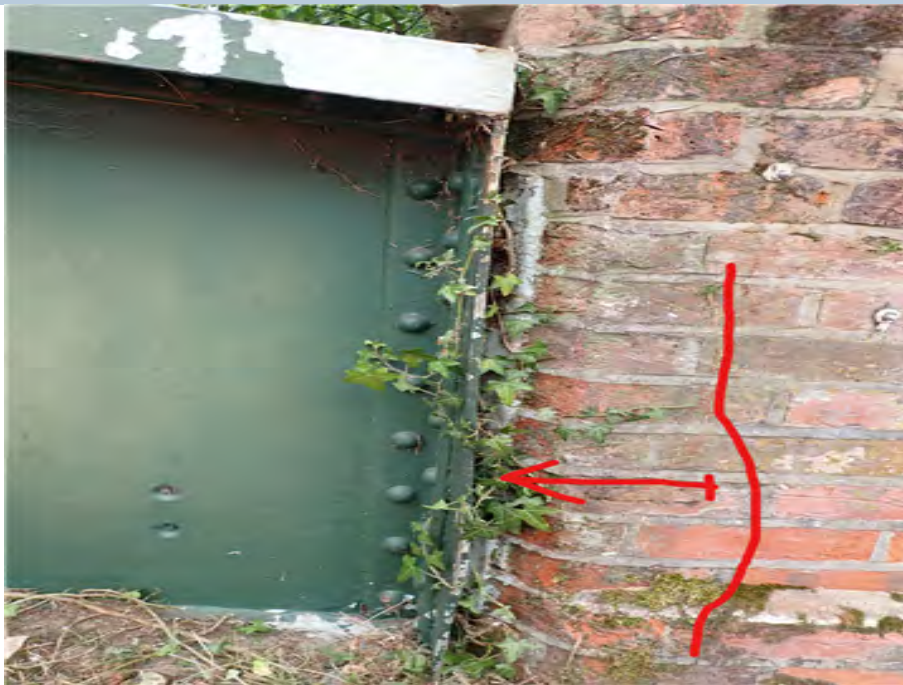
East Internal Edge Girder (south end)
 Deformation of end plate of 15mm due to impact damage.

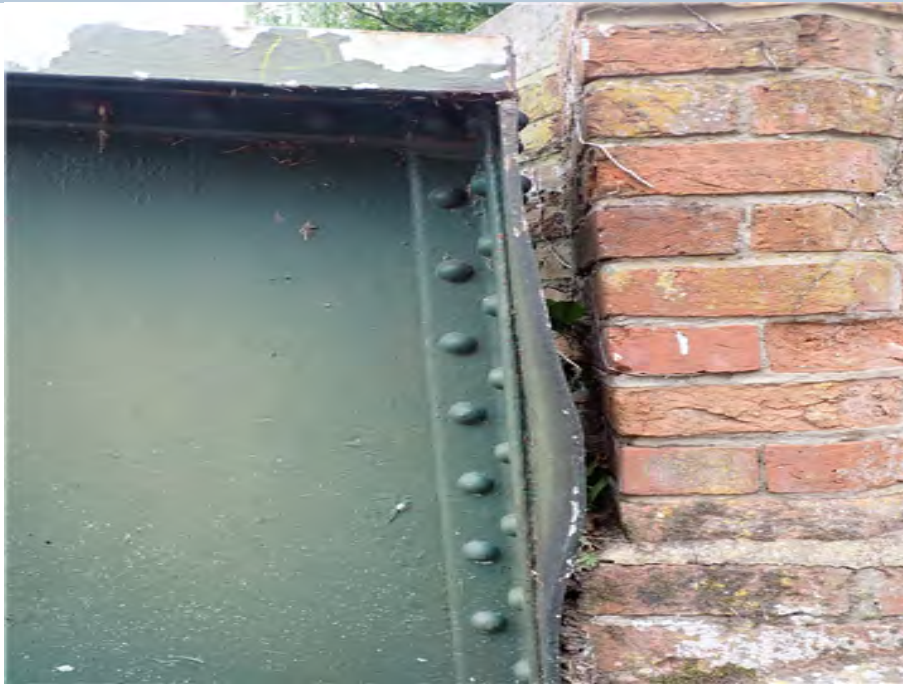
West Internal Edge Girder (north end)
 Deformation of end plate of 30mm due to impact damage.

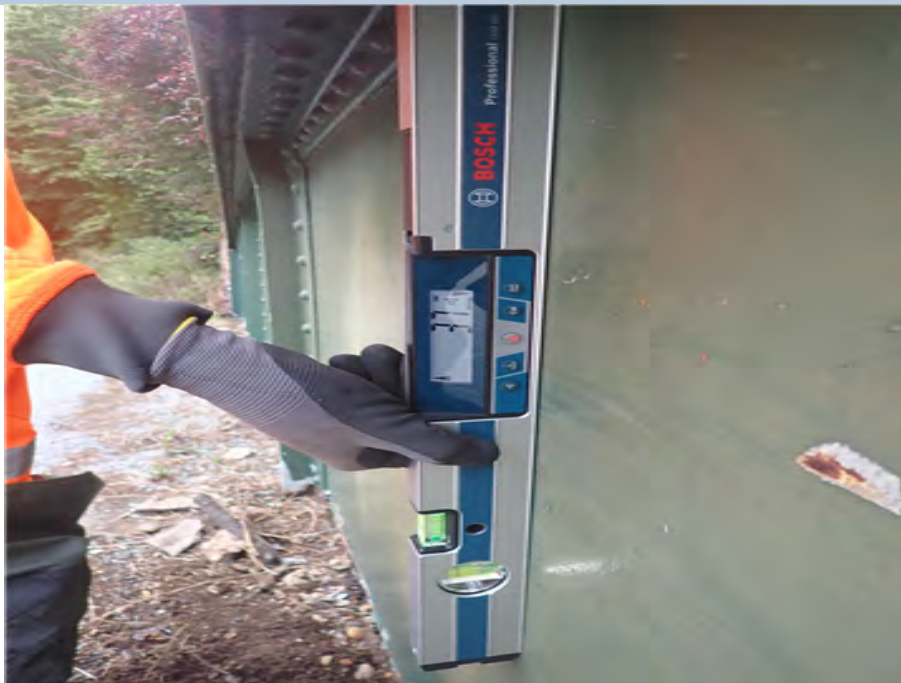
East Edge Girder Web (midspan)
 Rotation of 37mm/m. Overall Girder rotation of up to 65mm full height.

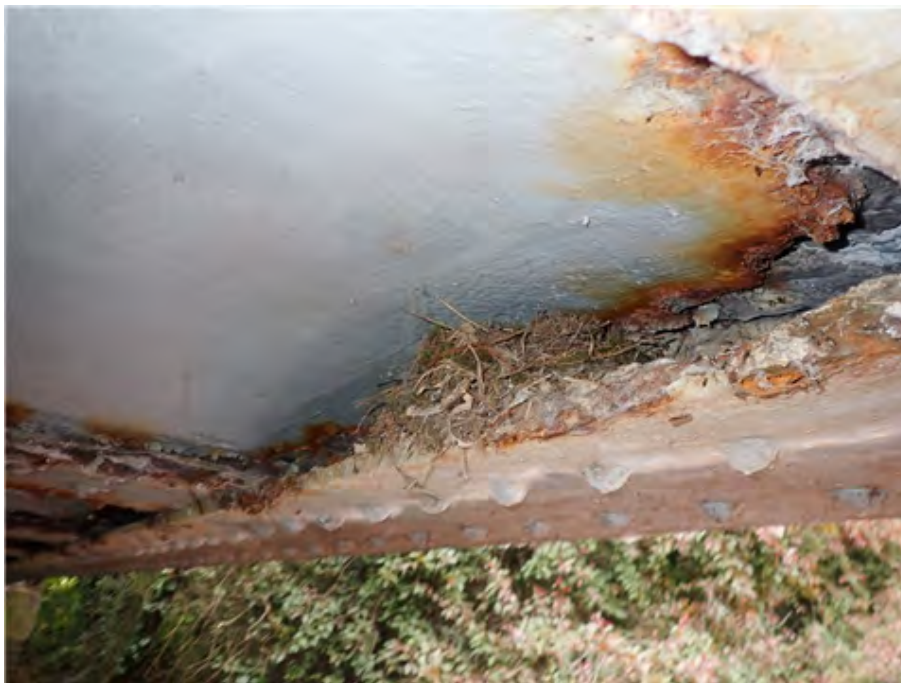
East Edge Girder Bottom Flange
 Disused birds nest on east edge girder inner bottom flange between the 2nd and 3rd transverse beam from the south.

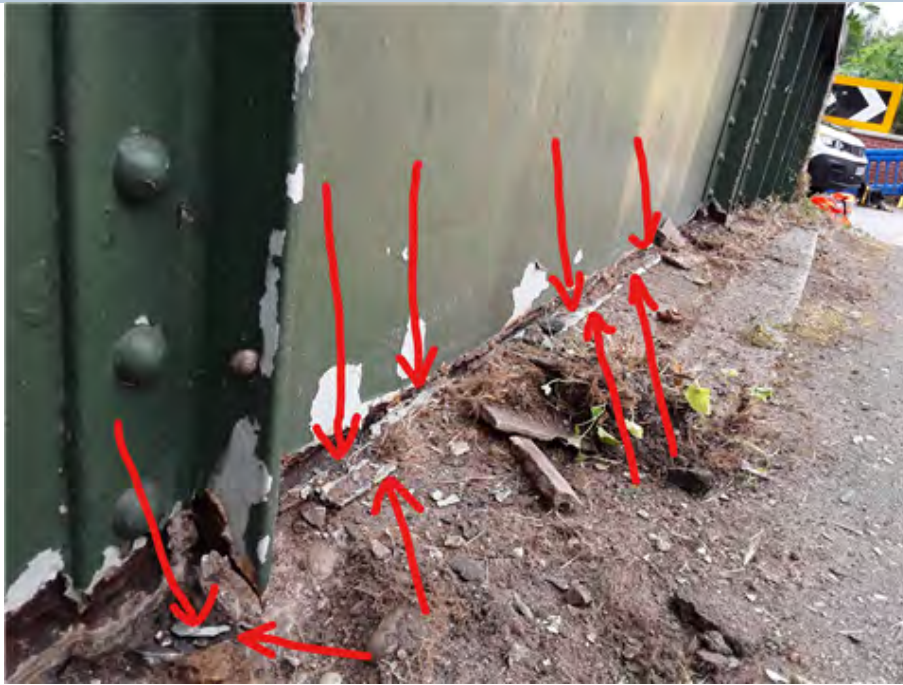
East Internal Topside Edge Girder (midpoint)
 Sealant broken up and cracked.

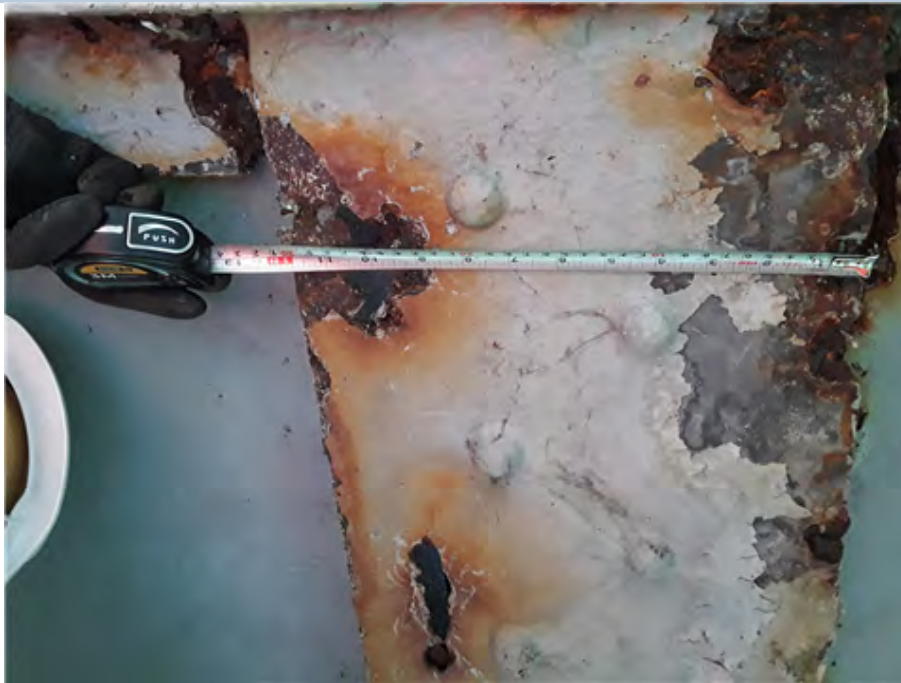
East Transverse Beam (At south end)
 Severe section loss and perforation due to corrosion. (1st beam in from the south)

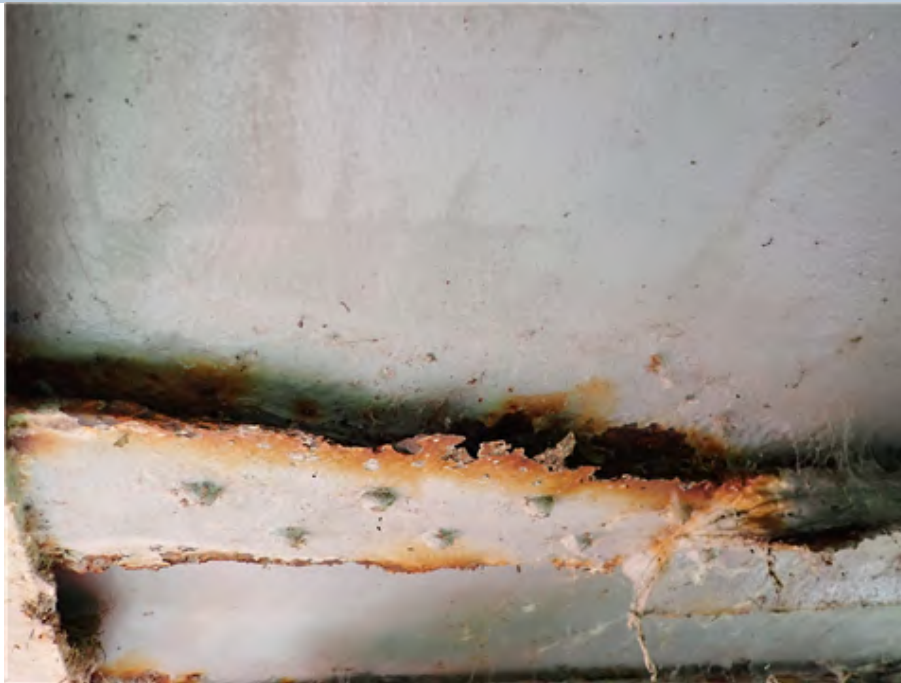
East Transverse Beam (At south end)
 Beam edges have corroded, causing section loss both in width and in thickness. (3rd beam in from the south)

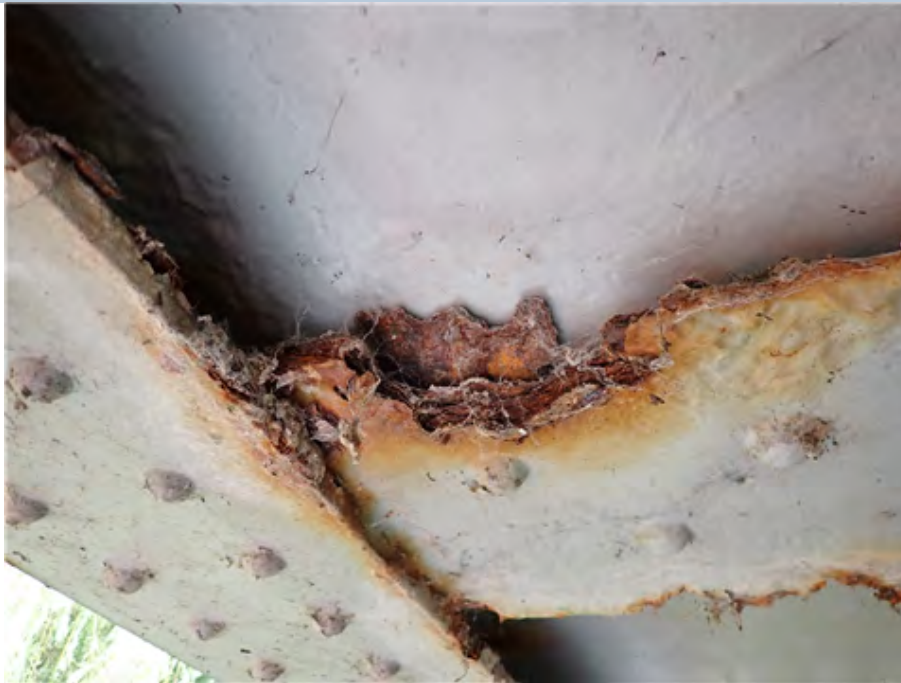
West Transverse Beam (at north end)
 Severe section loss and corrosion. (6th beam in from the south)

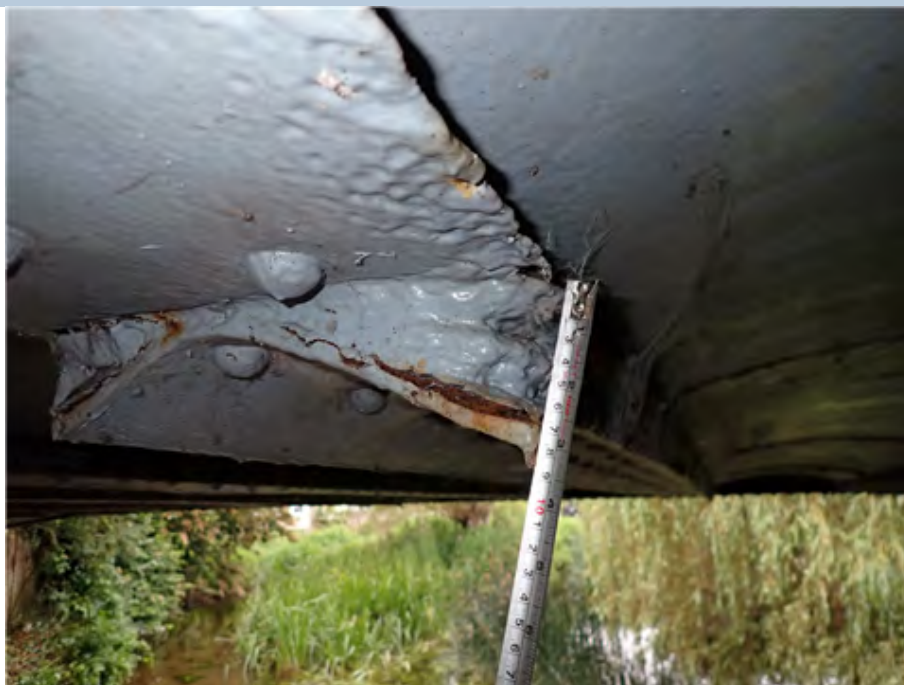
Transverse Beam Plate (East Side)
 Severe deflection due to corrosion up to 80mm. (6th beam in from the south)

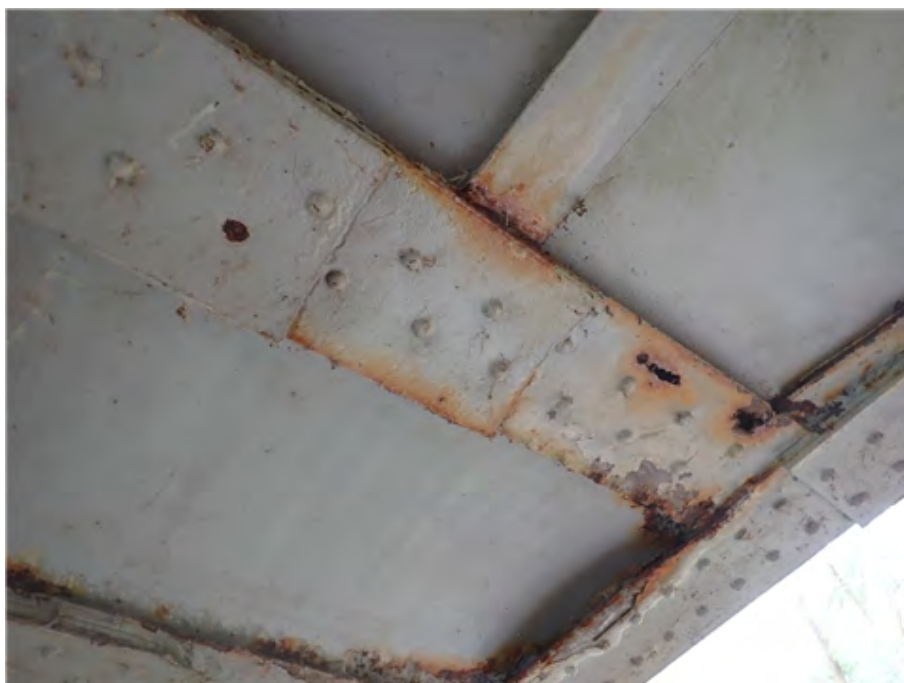
Riveted Transverse Beam Plate (East Side)
 Missing rivet due to deflection. (1st beam in from the south)

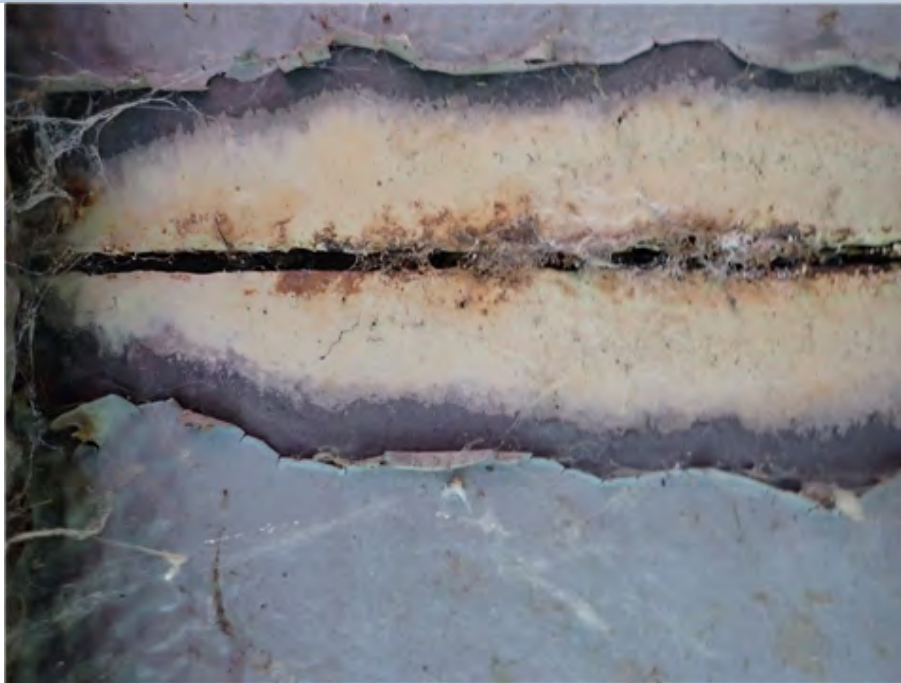
Jack Arch at East side.
 Jack arch hogging plate separation of up to 5mm to east side between the 4th and 5th transverse beam from the south end.

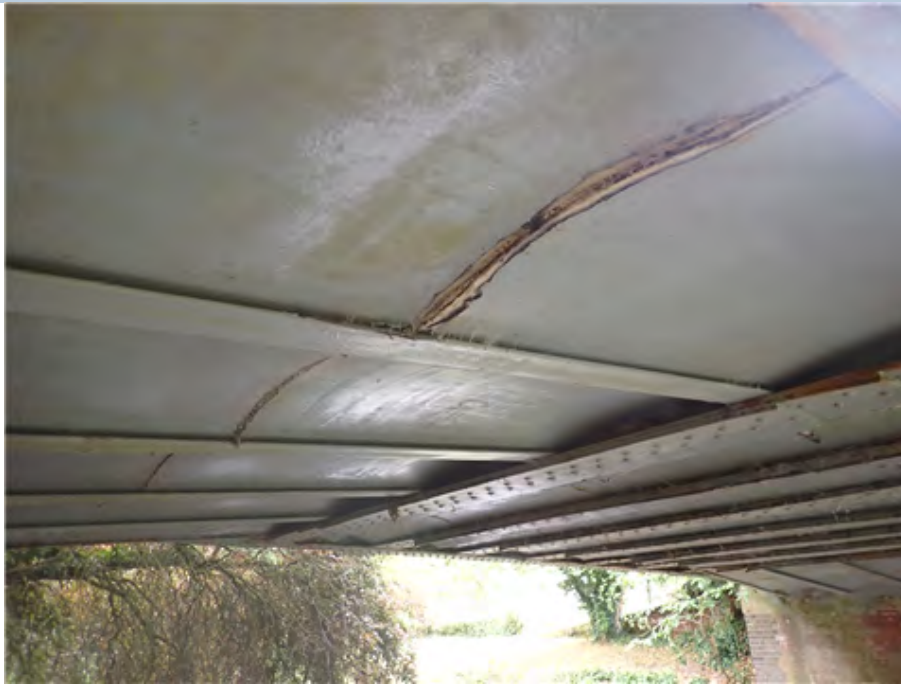
Jack Arch at West side at north end
 Jack arch misaligned 30mm to the west jack arch at north end.

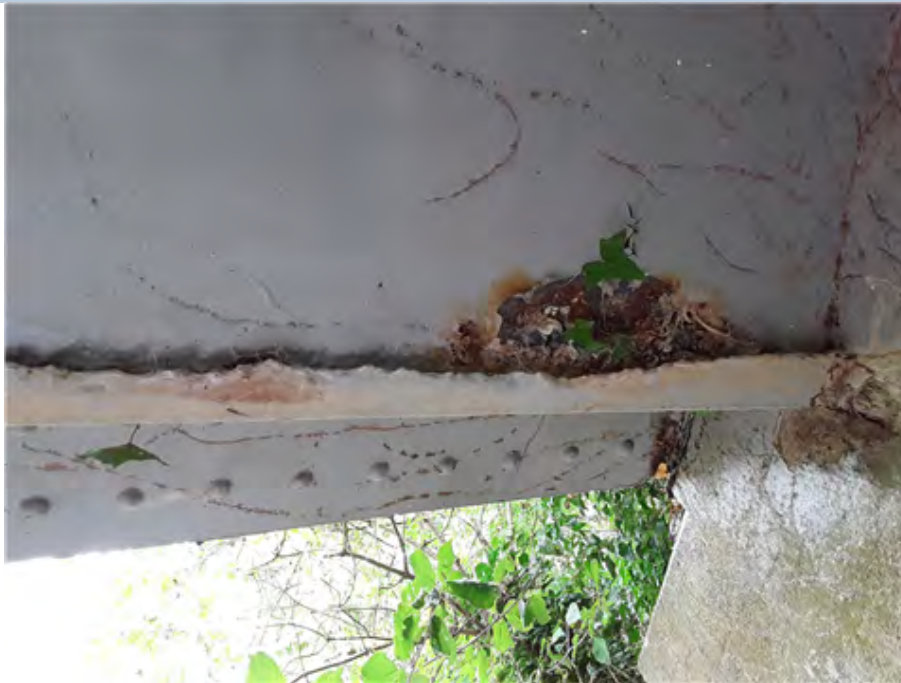
East Jack Arch at South End
 Section loss to jack arch hogging plate.

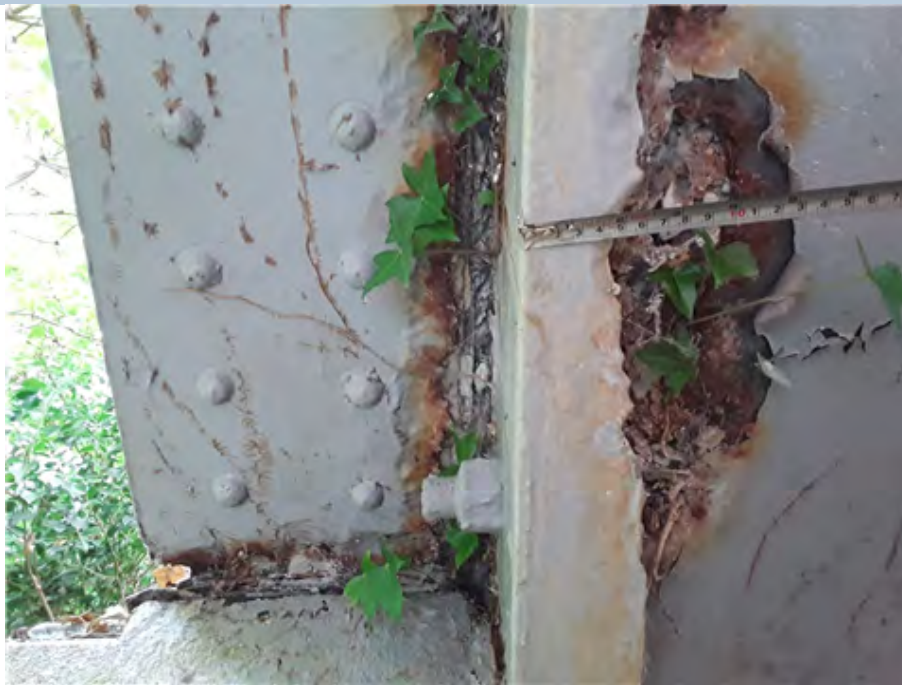
East Channel Section at South End.
 Section loss of up to 35mm to bottom flange of channel section.

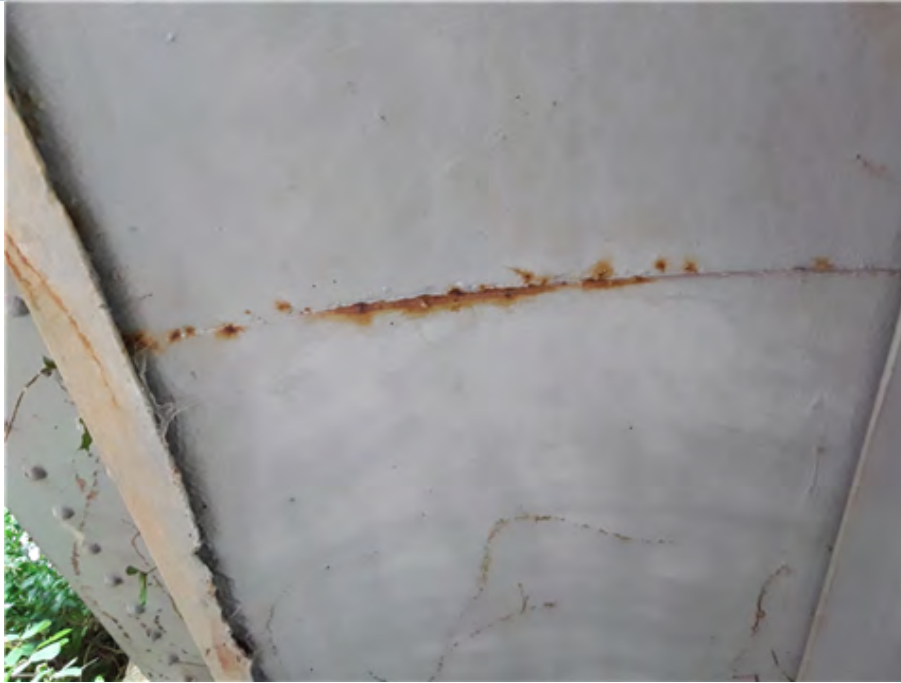
East Jack Arch Hogging Plate Joint (at south end)
 Minor corrosion of hogging plates at joint.

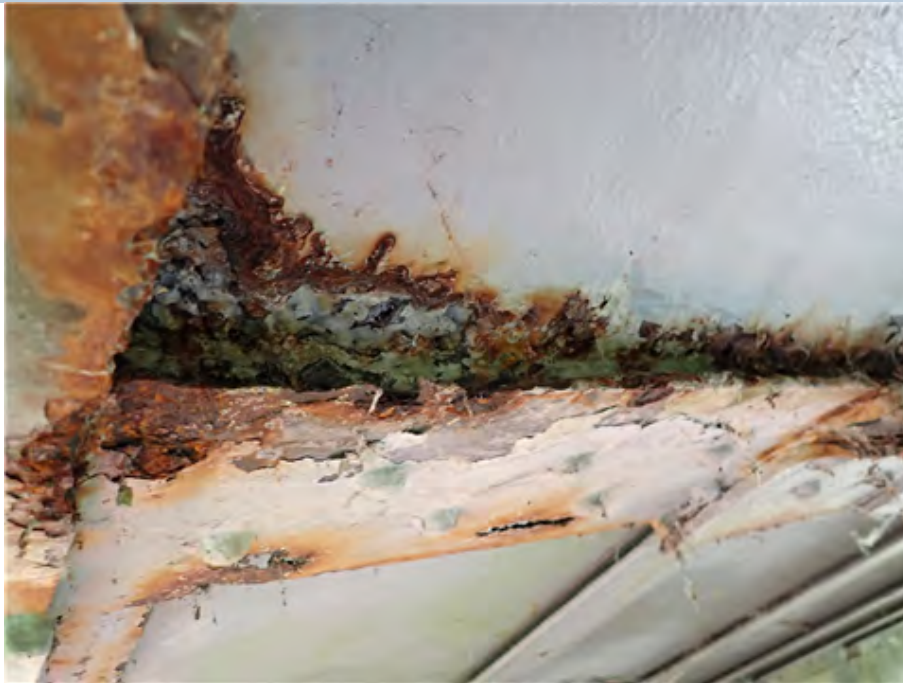
East Jack Arch Hogging Plate Edge (at south end)

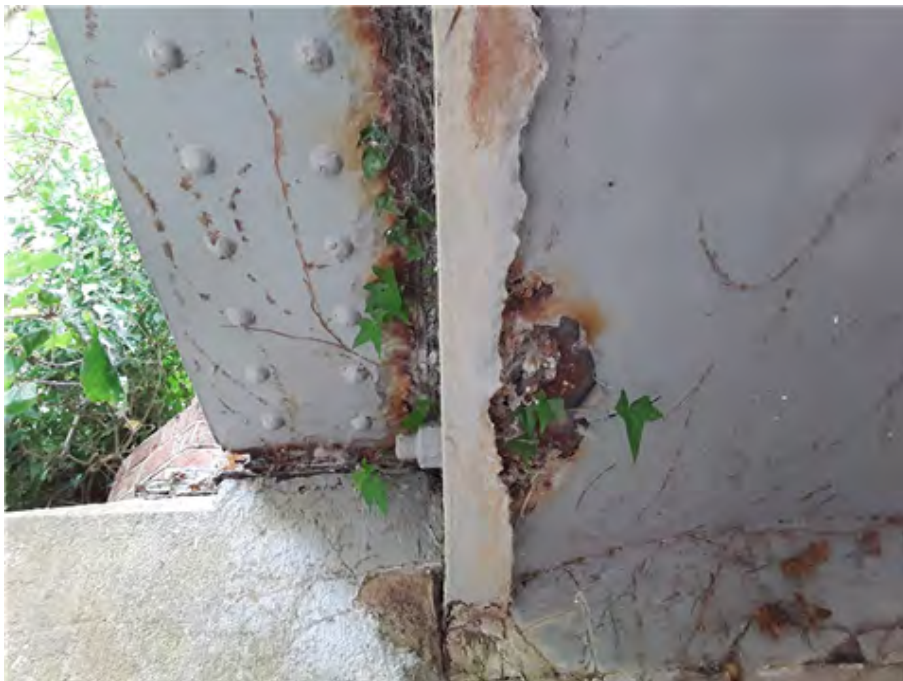
East Jack Arch at South End.

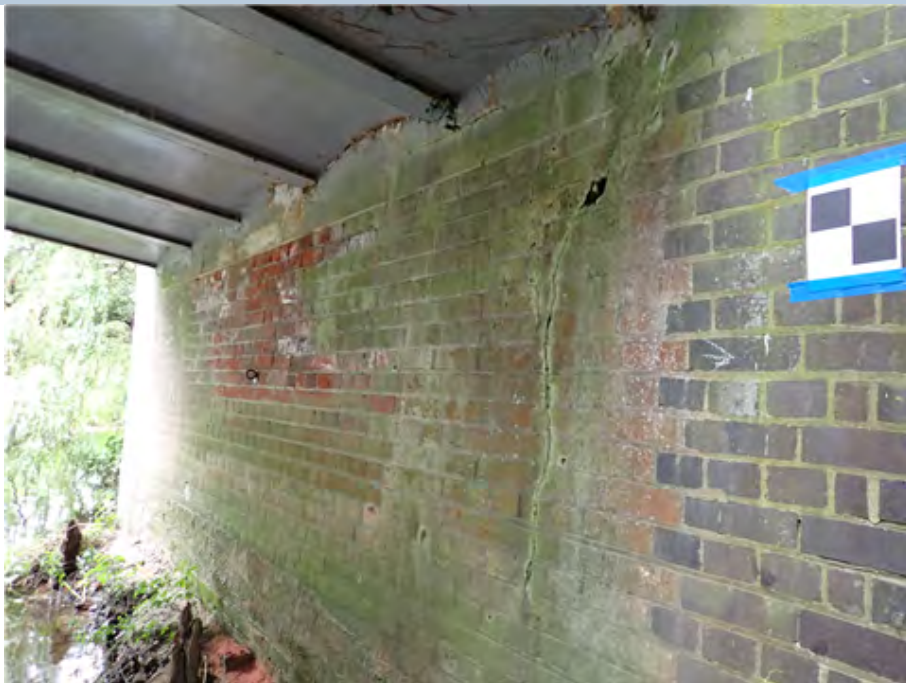
North Abutment (looking west)
 Full height crack indicating possible movement of foundations.

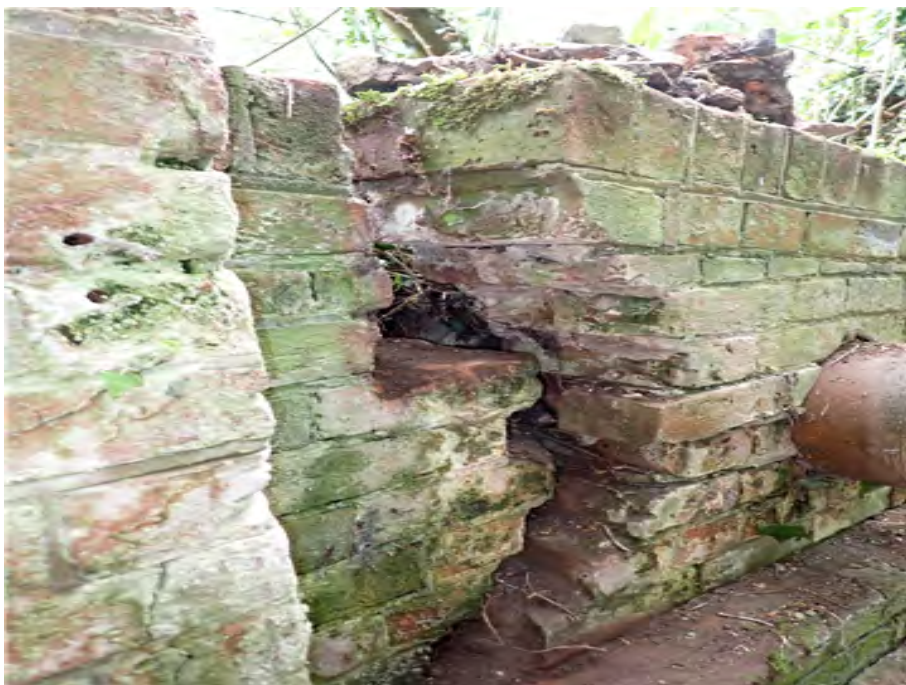
North East Wing Wall (looking north)
 Wing wall movement indicating possible movement of foundations.

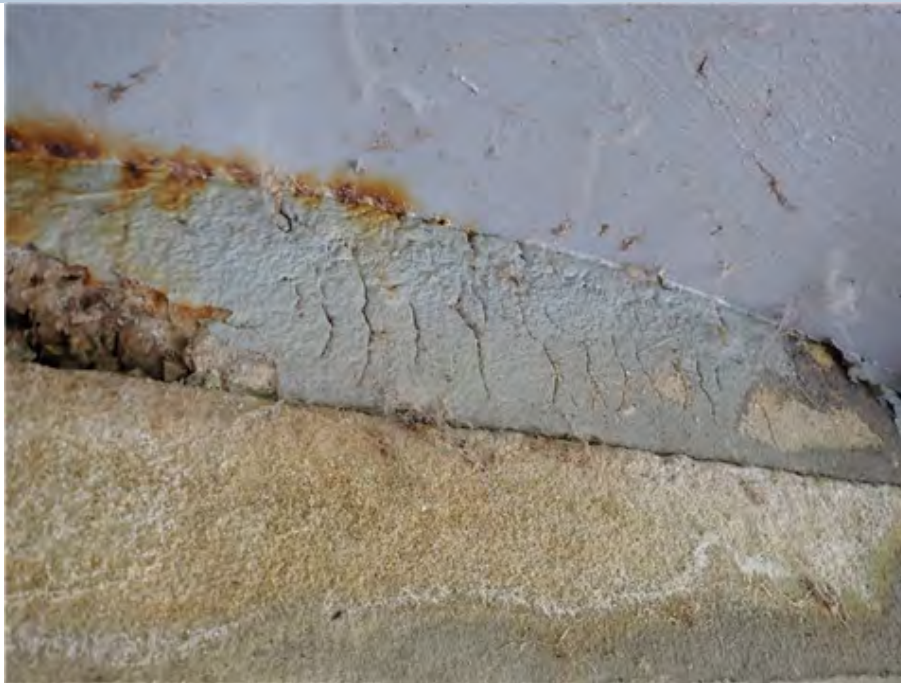
South Abutment (west end)
 Jack arch infill has shrinkage cracks.

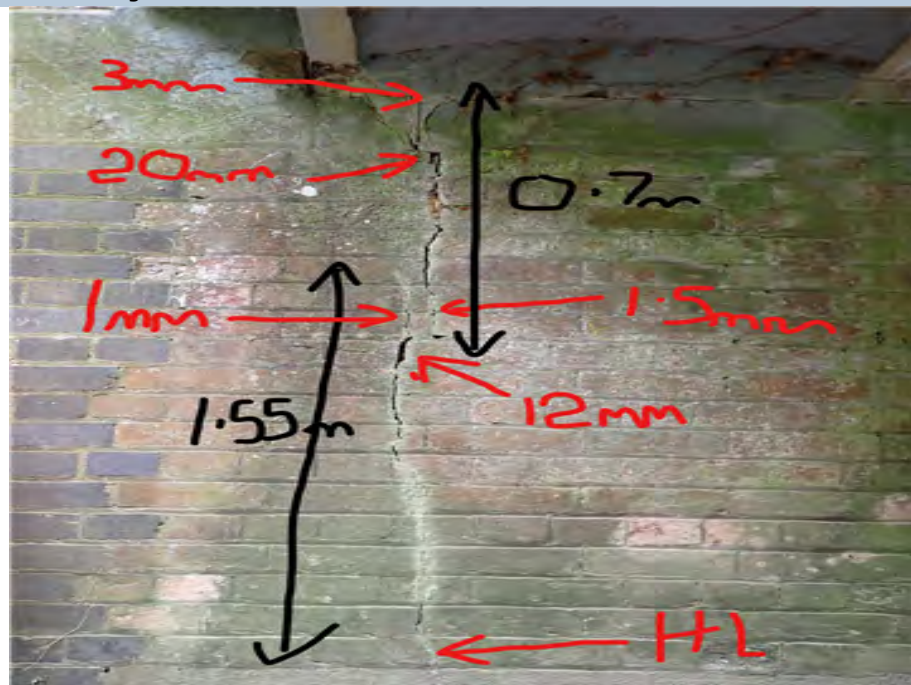
South Abutment (east end)
 Vertical cracks 2no. to abutment.

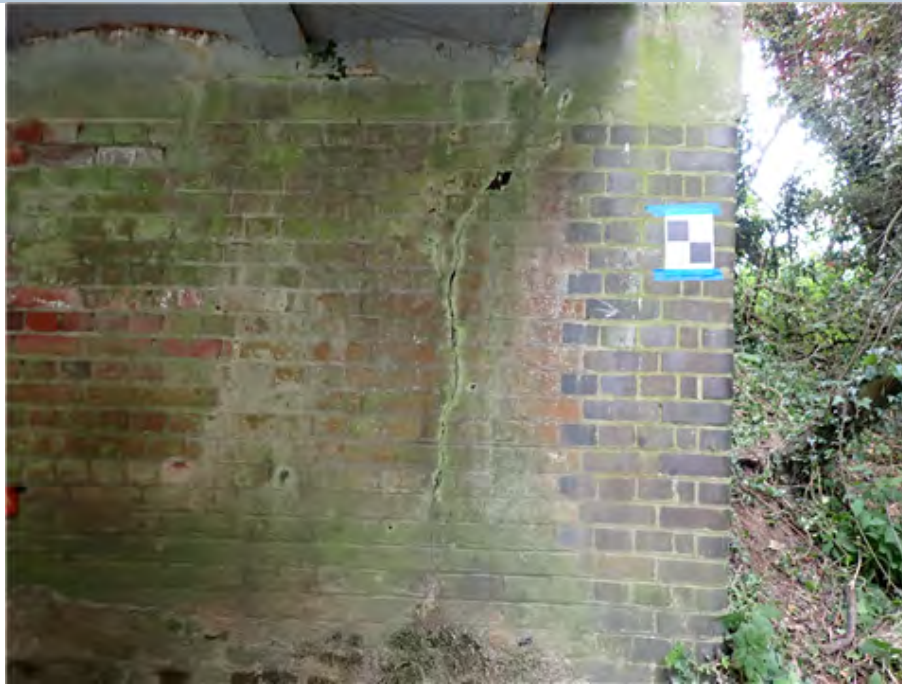
North Abutment (east end)
 Vertical crack to north abutment.
