Principal Inspection Report

Report Sections

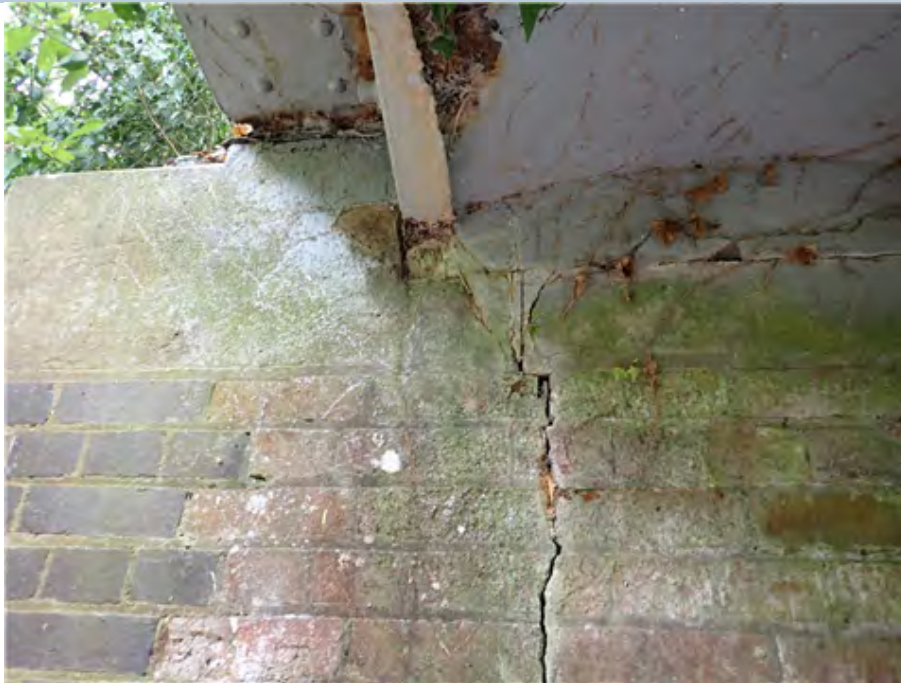
South abutment (east end)
 Spalling to jack arch concrete infill adjacent channel section (6m in from the west).

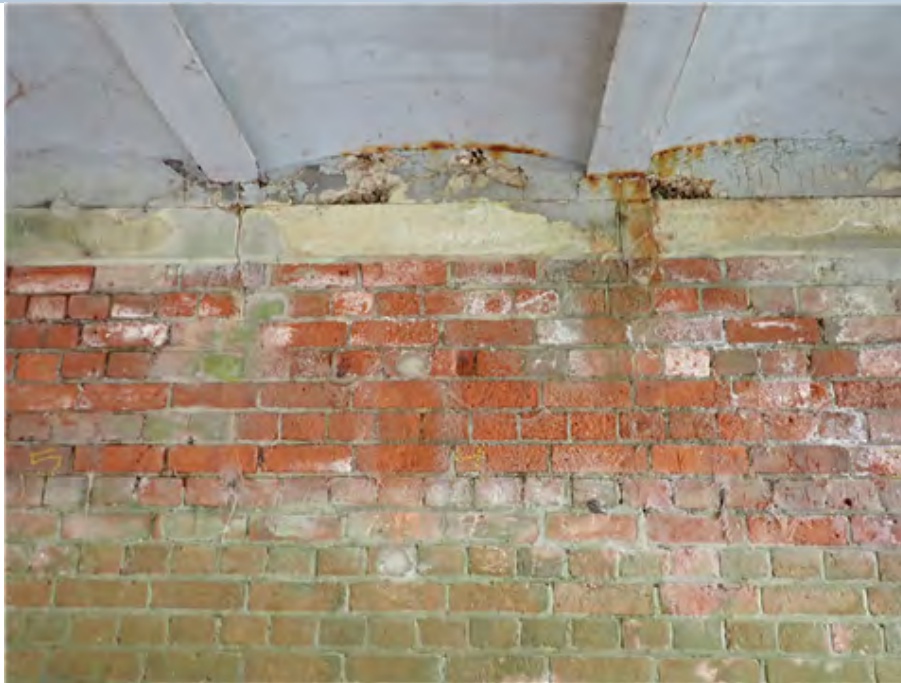
South Abutment
 Weathering to brick faces

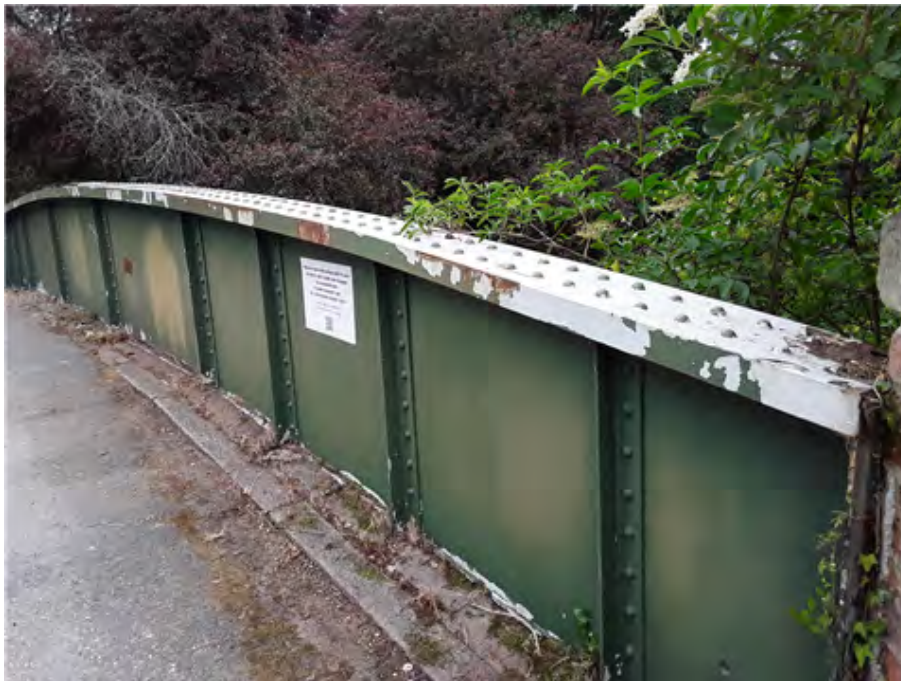
East Edge Girder Top Flange (looking north)
 Protective paint top coat flaking.

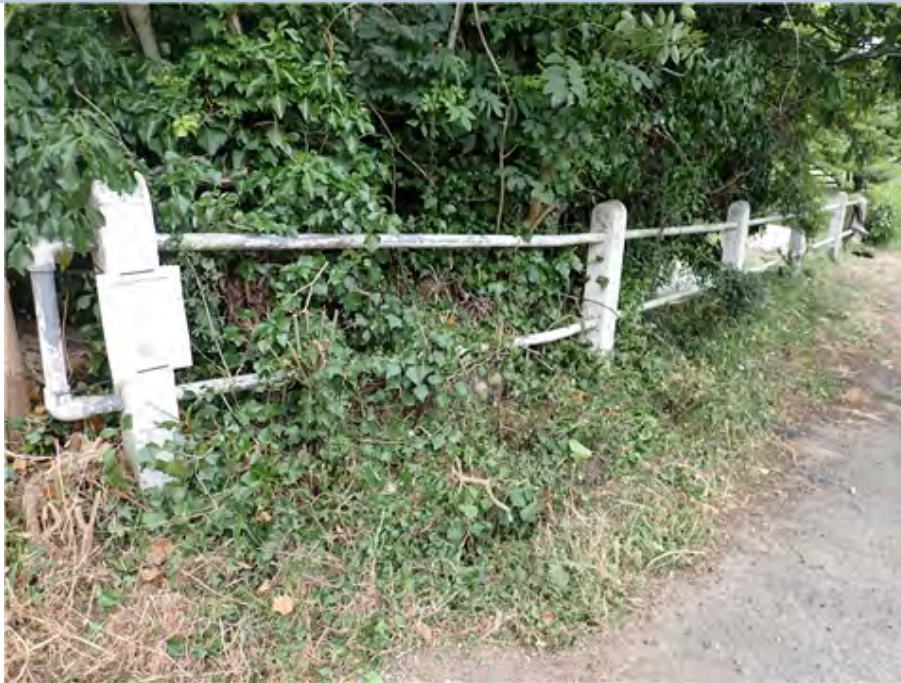
South East Approach Rail
 Protective paint top coat chipped and flaked on railings and concrete posts.

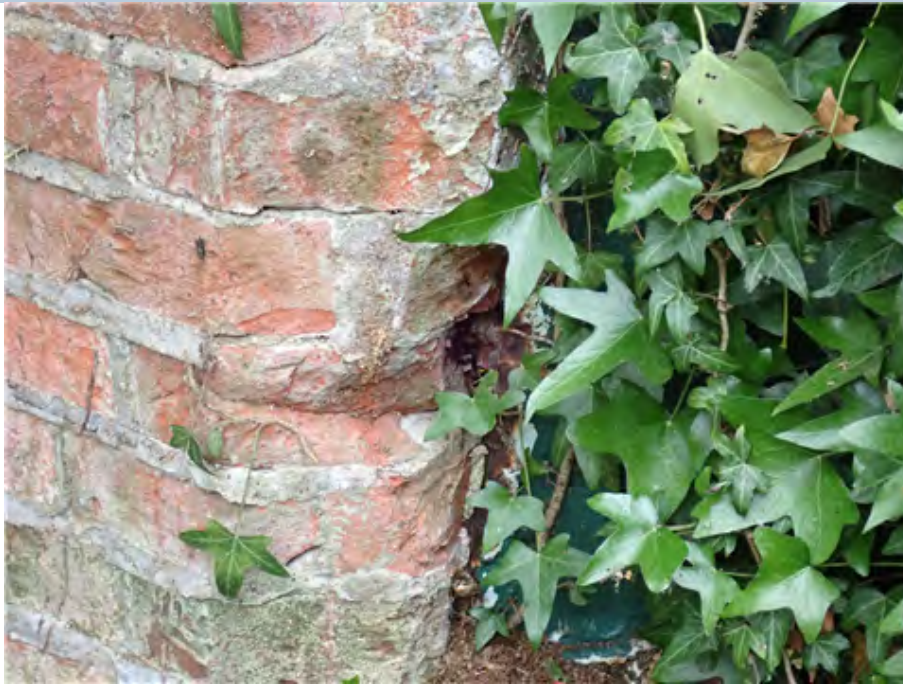
South East Pilaster (NE corner)
 Bees nest in pilaster void just above abutment.

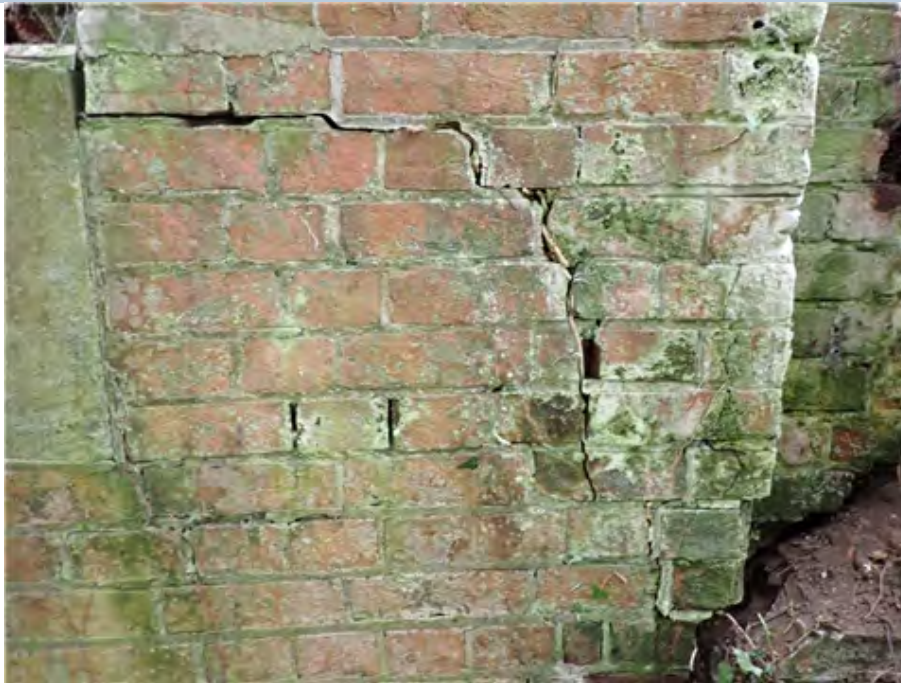
North East Pilaster (east face)
 Stepped diagonal crack extending from bearing stone to wing wall open 3.5mm with vegetation roots growing in the gap.

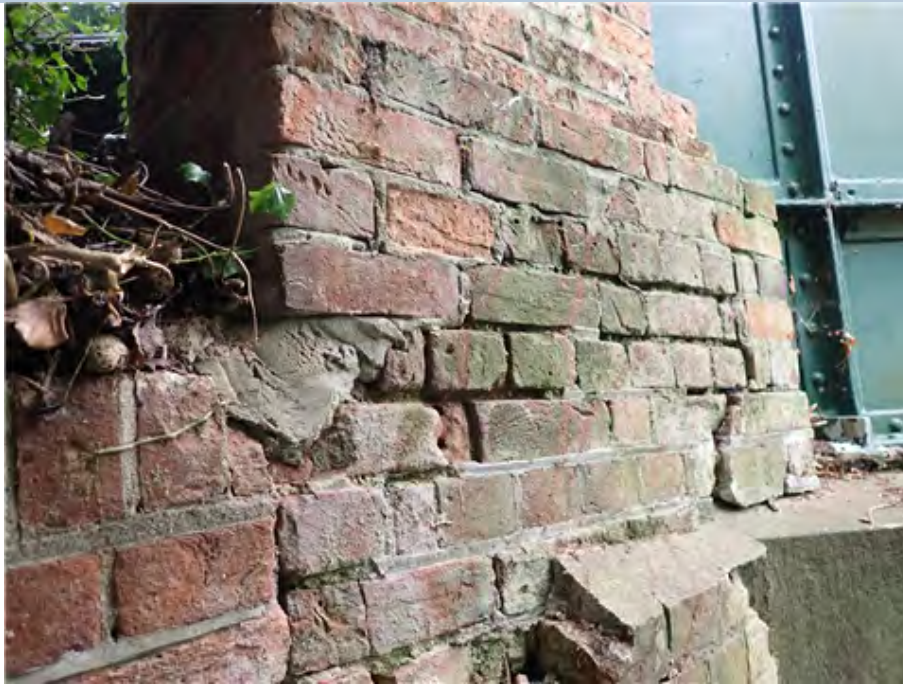
North West Pilaster (west face)
 Pointing loss of up to 10mm in depth between bricks.

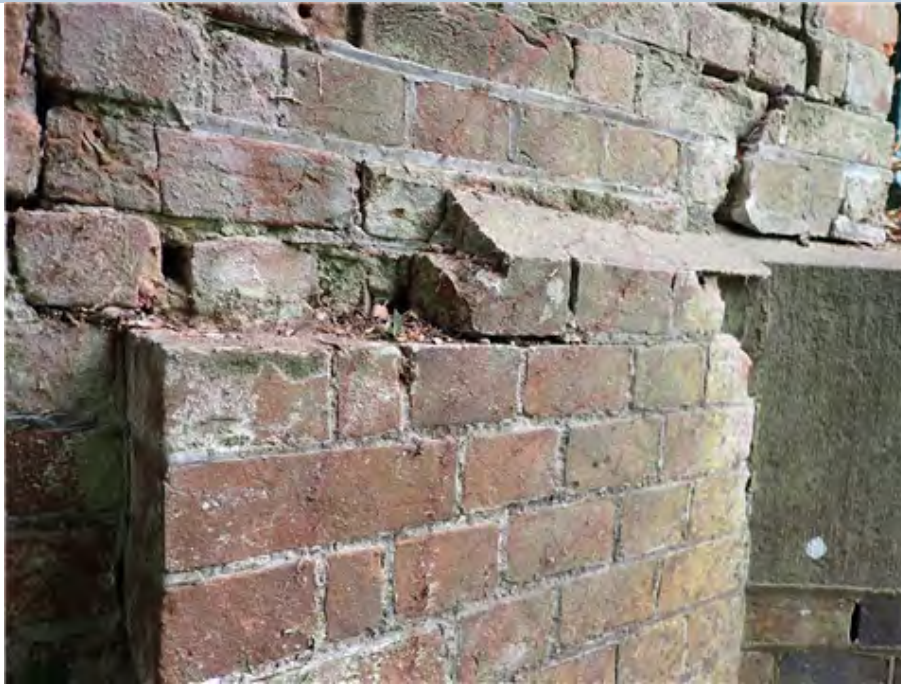
North West Pilaster (west face lower section)

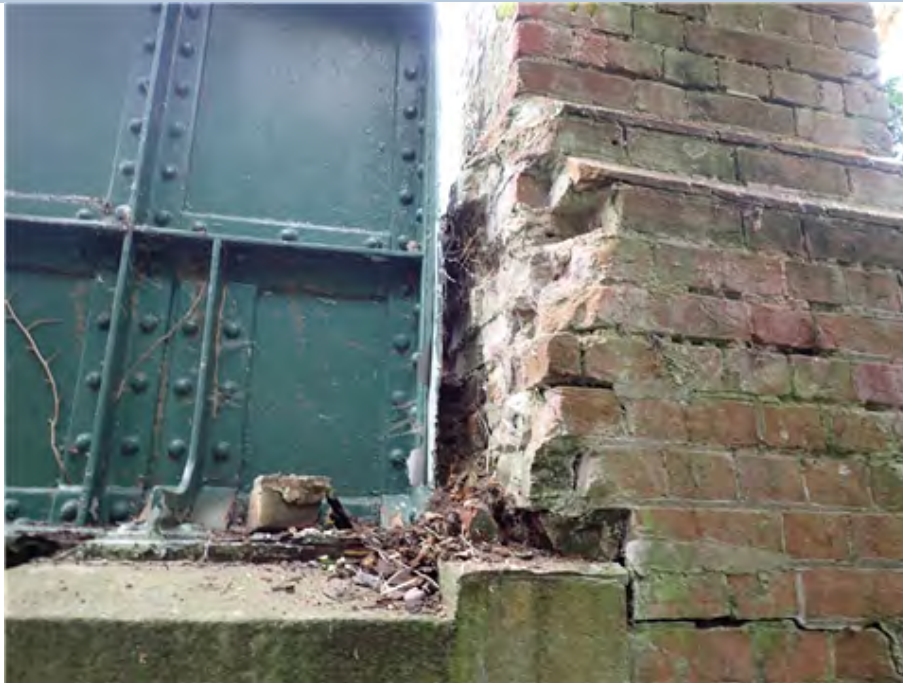
North East Pilaster (south east corner)
 Bricks broken up, loose and missing.

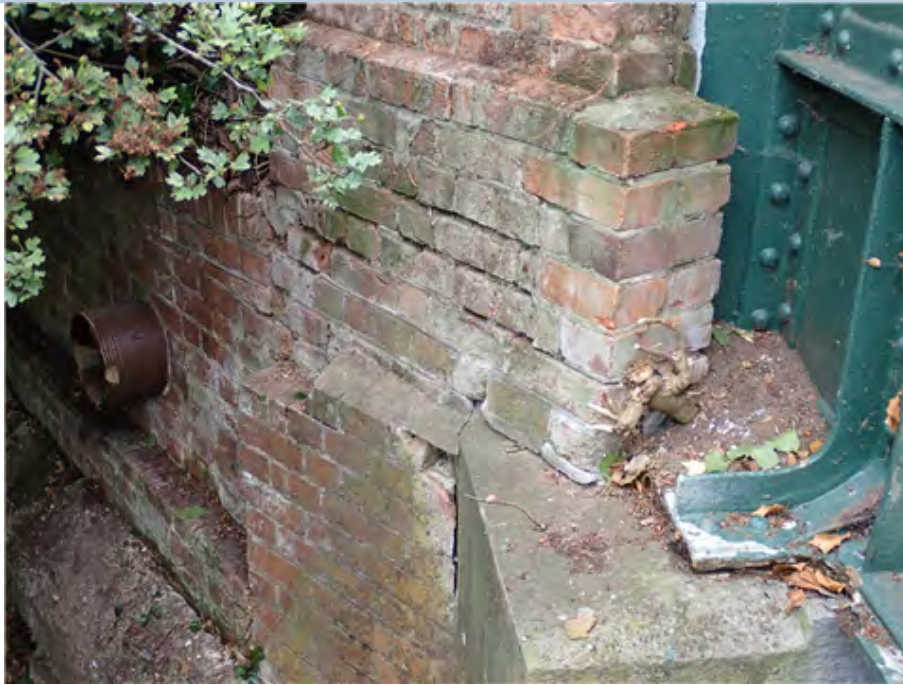
North West Pilaster (south face)
 Ivy stump adjacent pilaster.

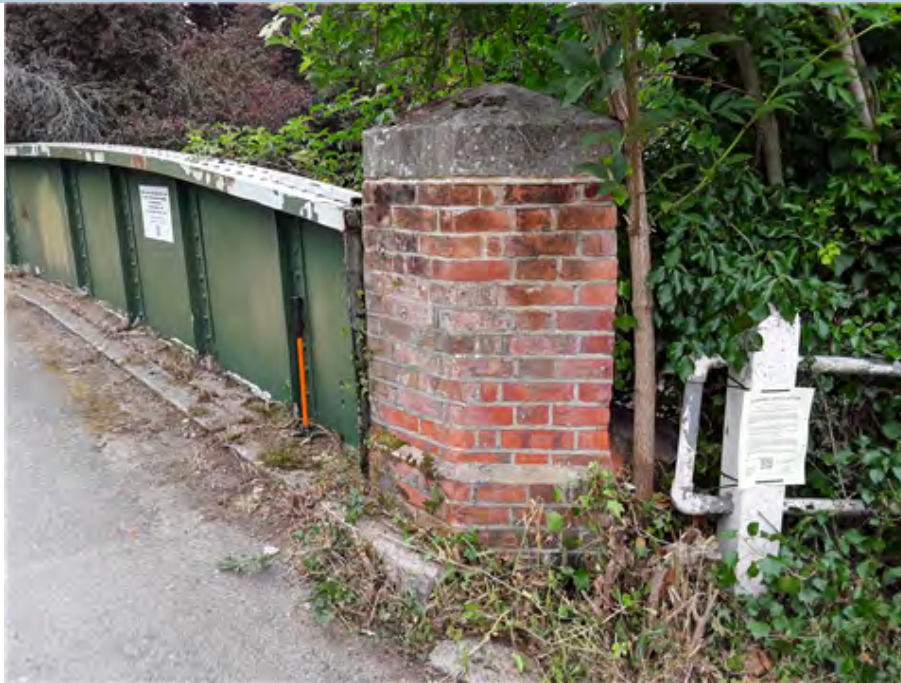
South East Pilaster (south face)
 Tree growing adjacent SE corner of pilaster.

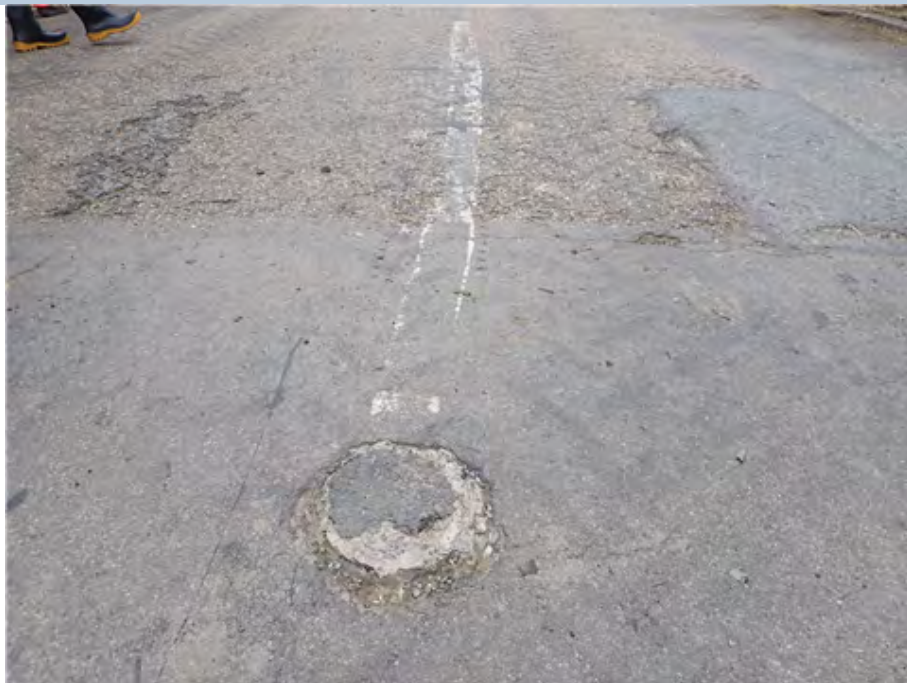
Carriageway Surface (south end)
 Shallow potholes 3no. to south end.

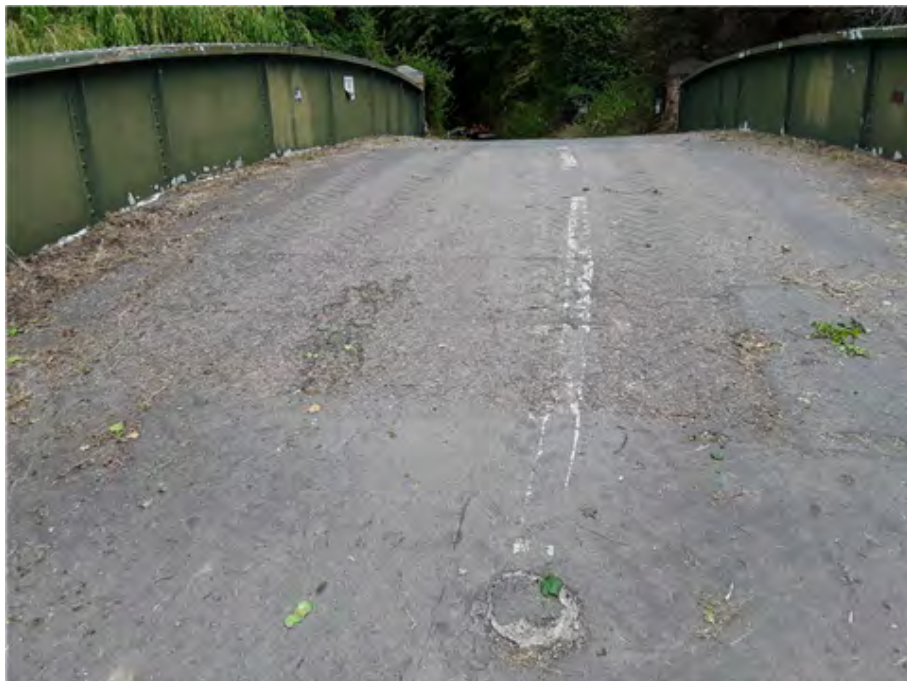
Carriageway Surface (looking north)
 Tracking to both carriageway lanes for 10m.

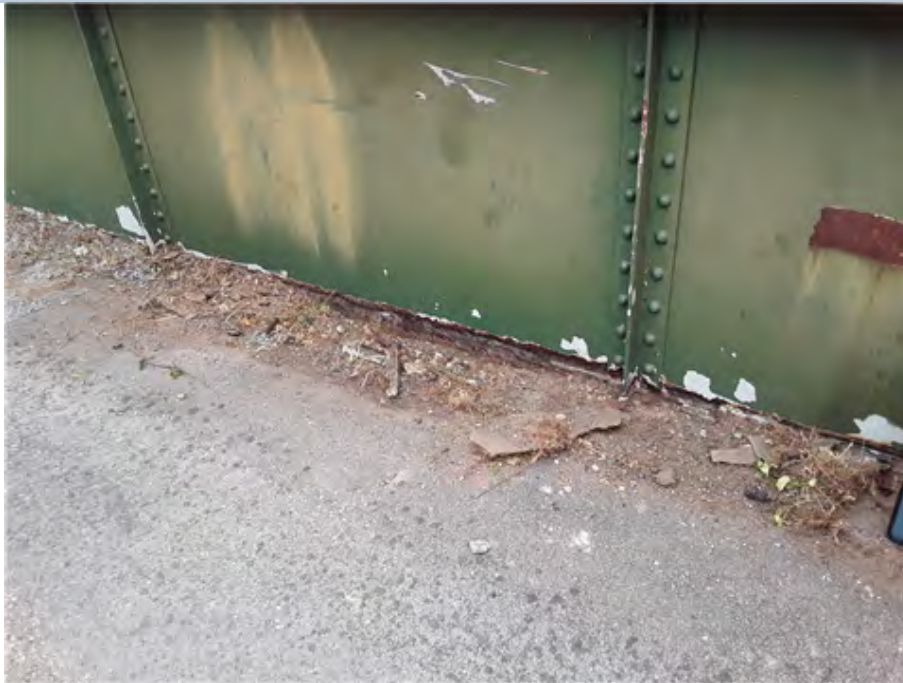
East Carriageway (midspan)
 Concrete edge fillet broken up.

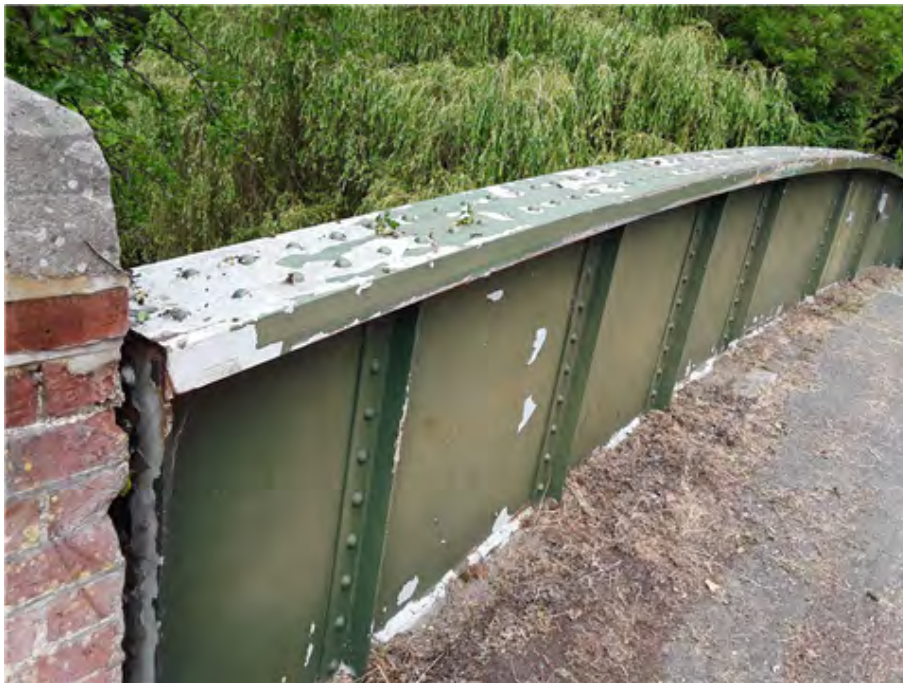
West Carriageway Edge
 Grasses and weeds growing along between edge kerbing and edge girder.

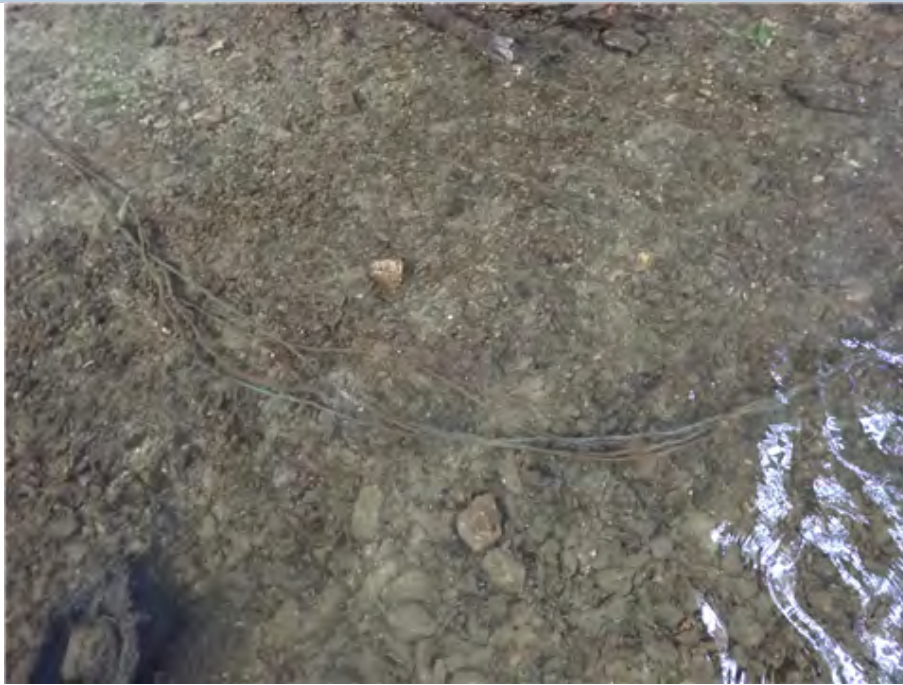
North River Bed (4m in from the west)
 Submerged rope and broken timber post
 (bottom left)

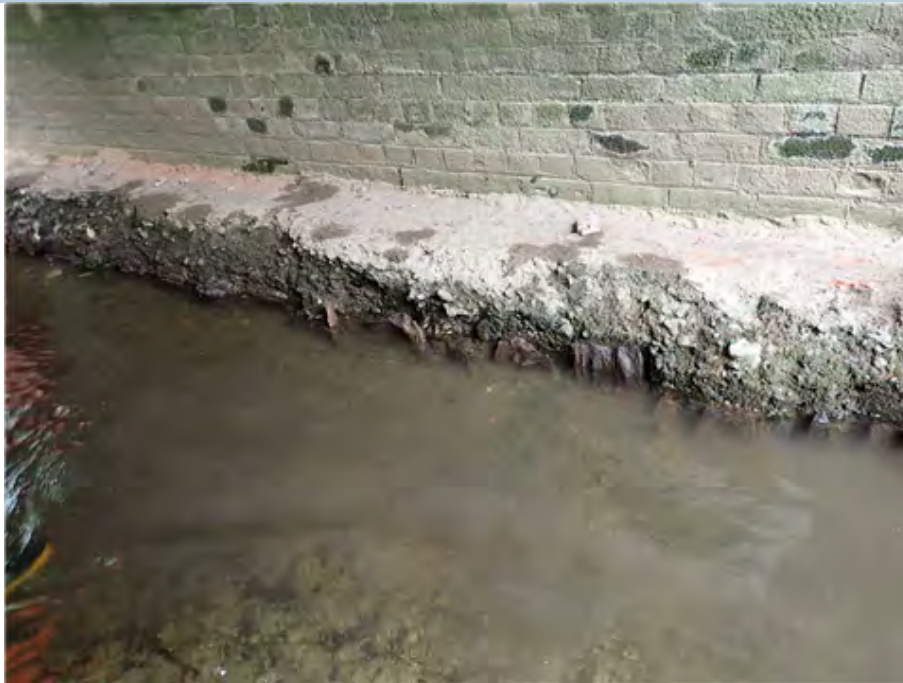
River Bed in front of South Abutment.
 Broken timber posts at river bed edge.

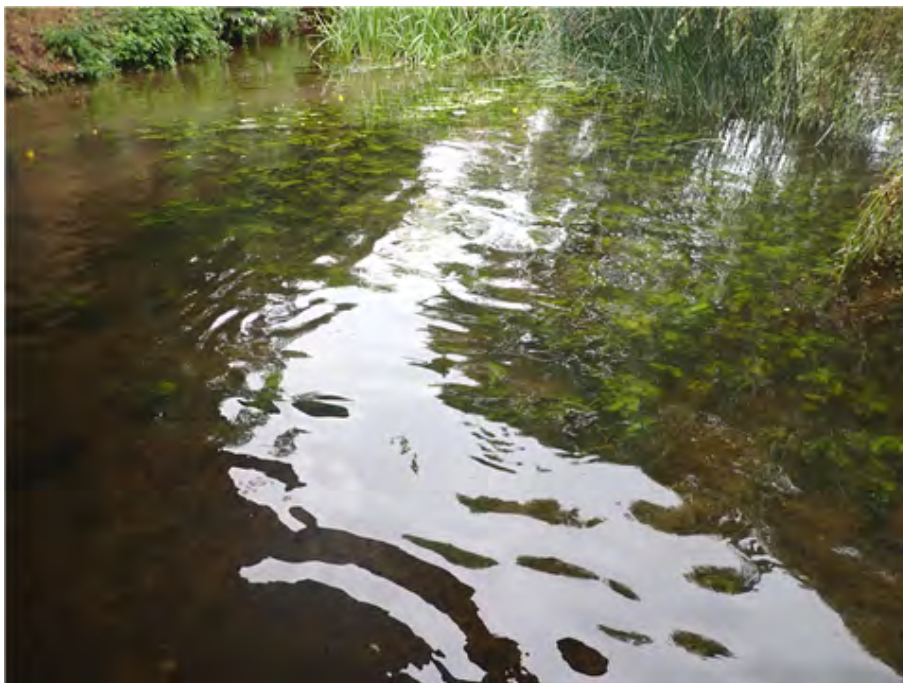
West River Bed (midspan)
 Minor scour, slightly deeper area of river bed.

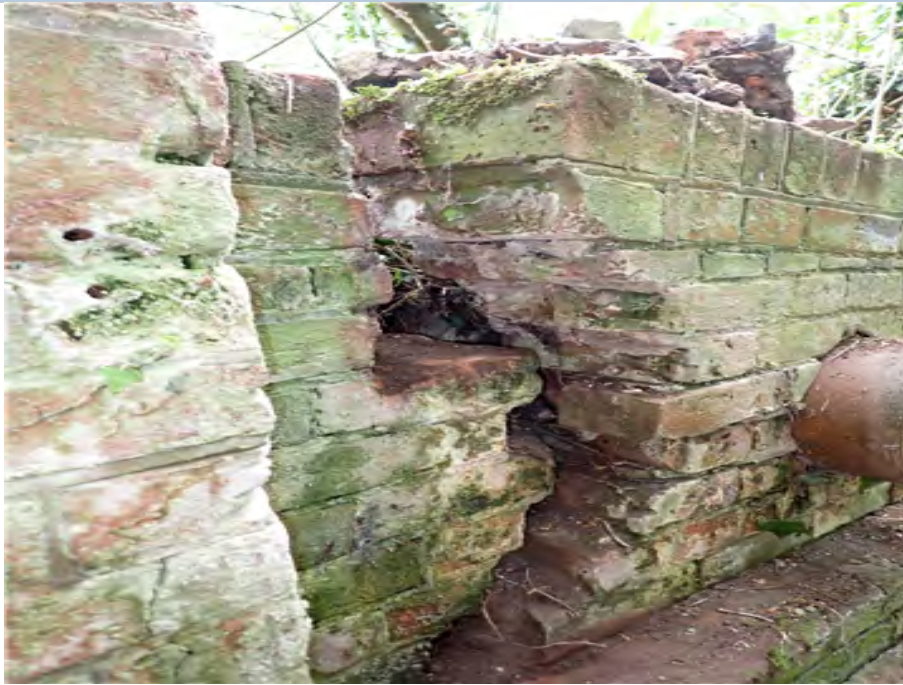
North East Wing Wall (looking north)
 Wing wall cracked through over full height, separated and significantly displaced.

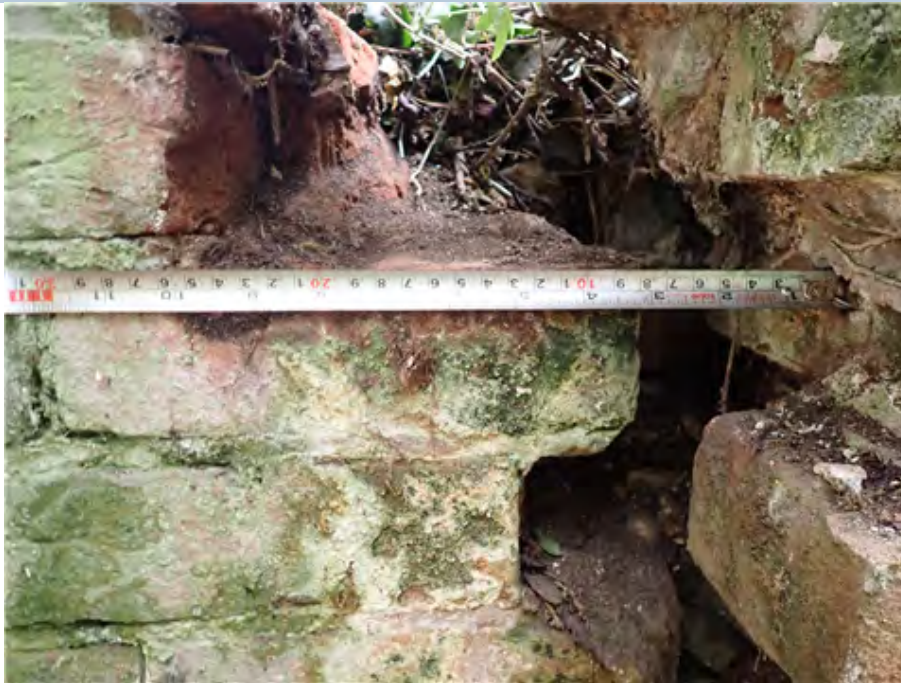
North East Wing Wall (looking west)
 Gap separation maximum 250mm at widest part.

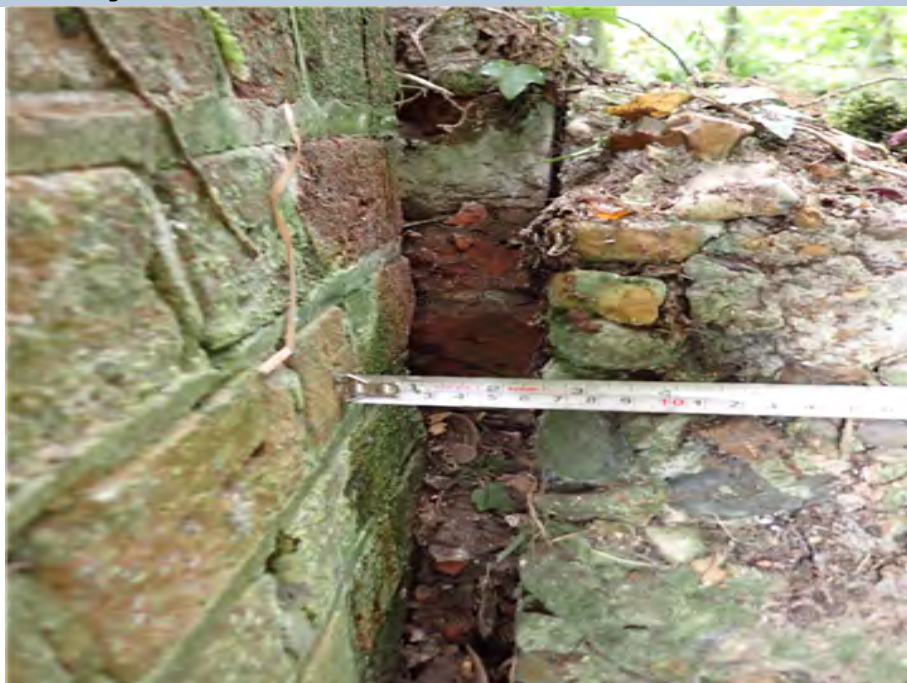
North East Wing Wall (looking north)
 Concrete plinth at the base of wing wall displaced by 60mm.

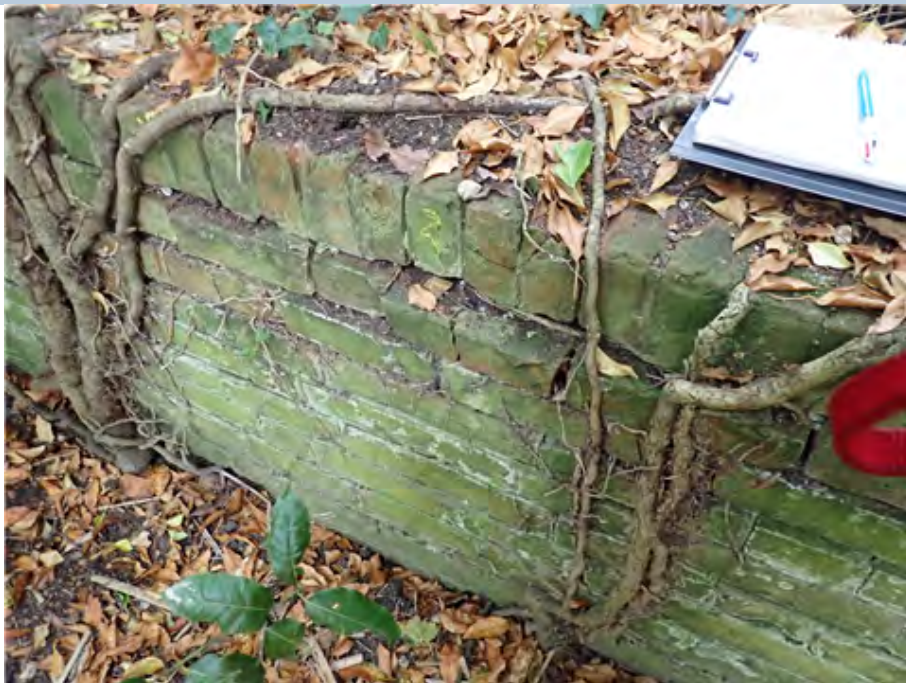
South West Wing Wall (west end)
 Brickwork displaced 30mm northwards.

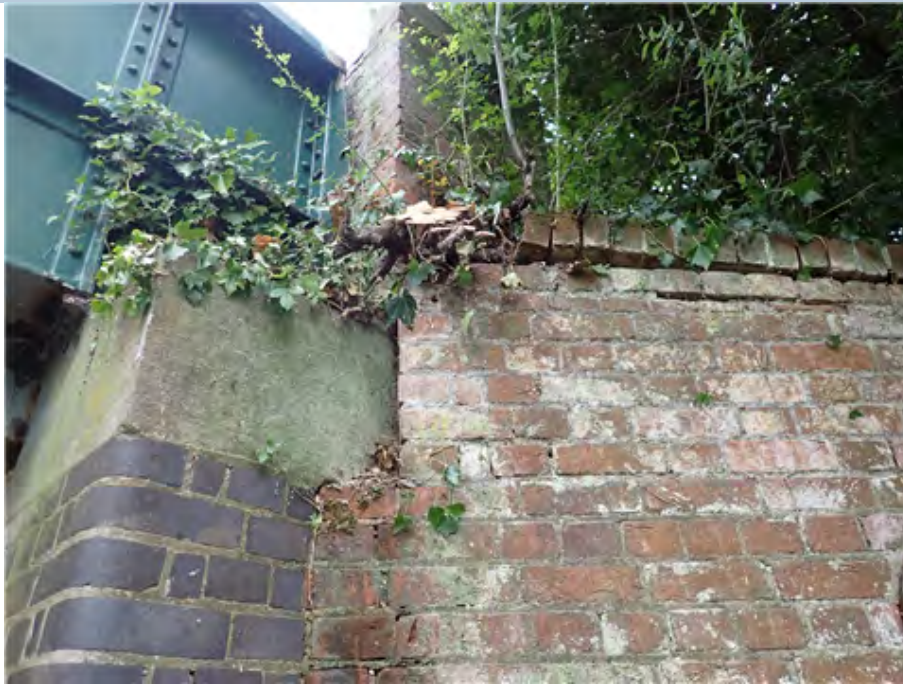
South West Wing Wall (east end)
 The top two brick courses were separated up to 60mm due to tree roots.

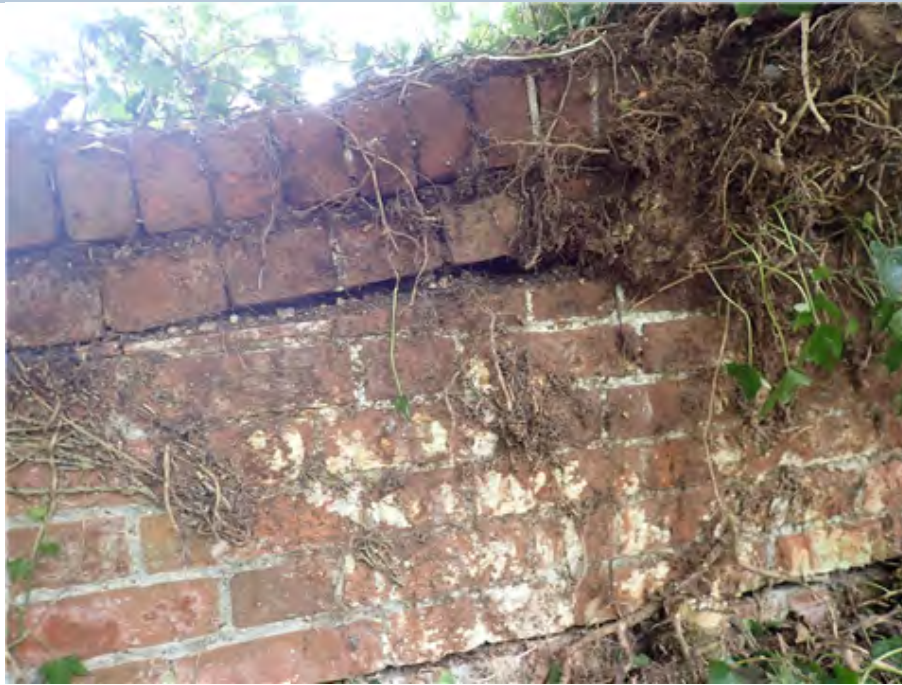
South East Wing Wall
 Tree root damage to wing wall 4m in from the west,

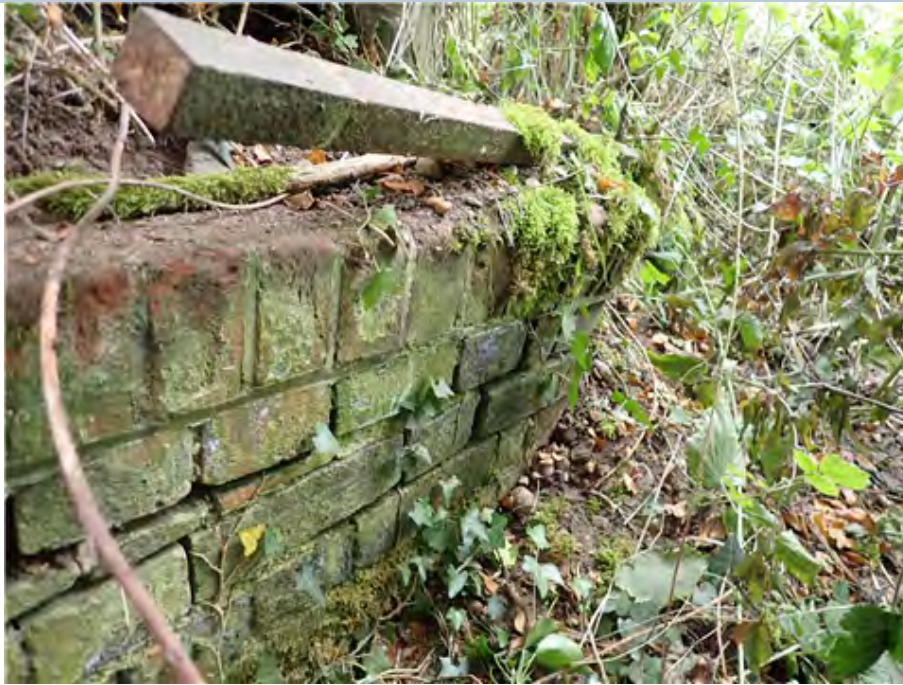
North East Wing Wall (looking north)
 Wing wall leaning due to adjacent tree.

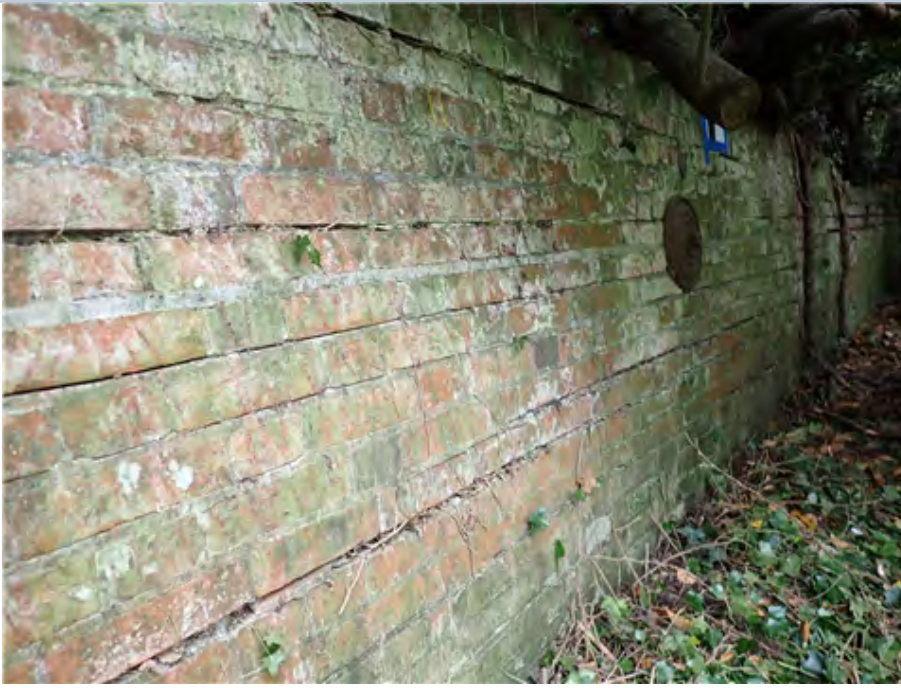
South West Wing Wall (looking west)
Moderate bulging to midpoint of brickwork.

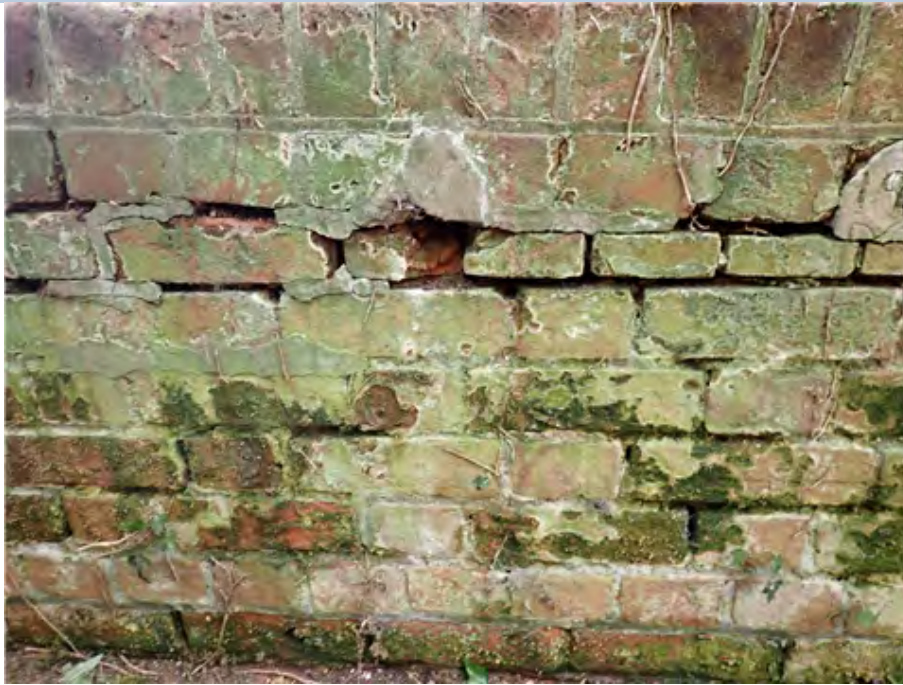
North East Wing Wall
 Area of bricks breaking up to upper section.

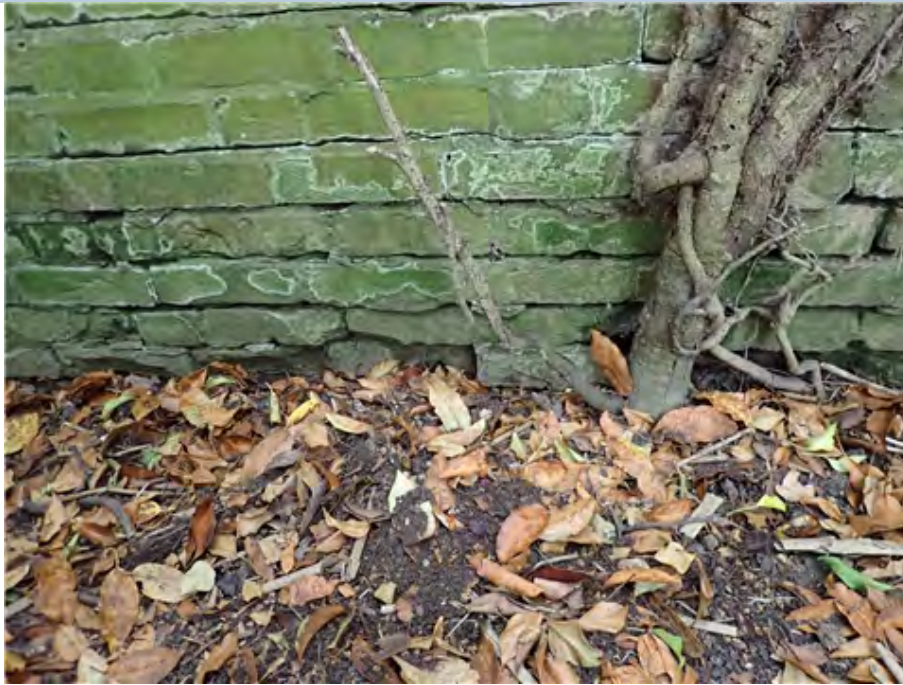
South West Wing Wall (west end)
 Brickwork breaking up at bottom of wing wall to a maximum depth of 40mm.

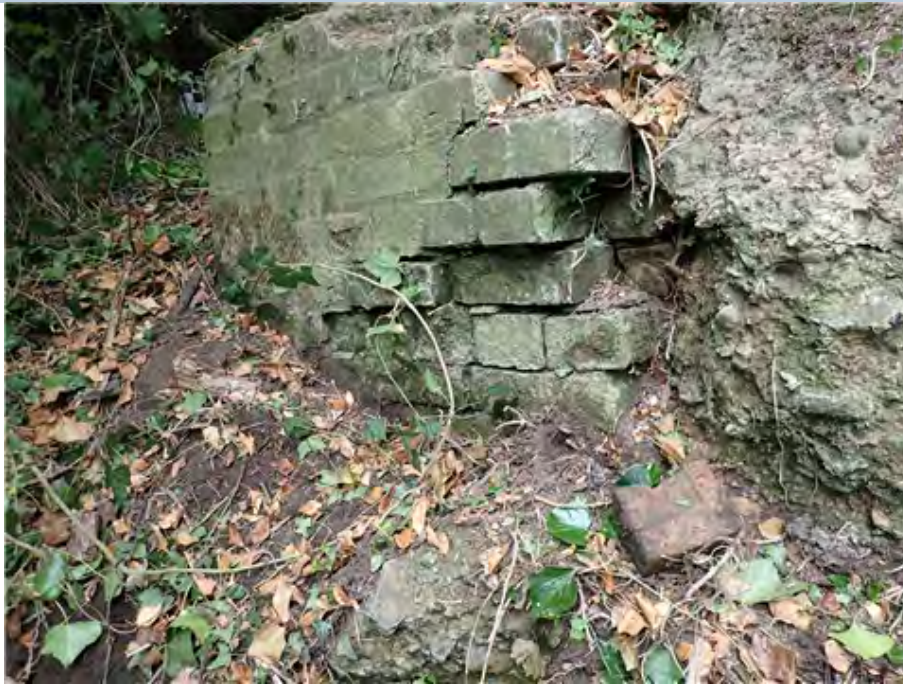
North West Wing Wall (lower section)
 Bricks breaking up and loose at south end of the wall.

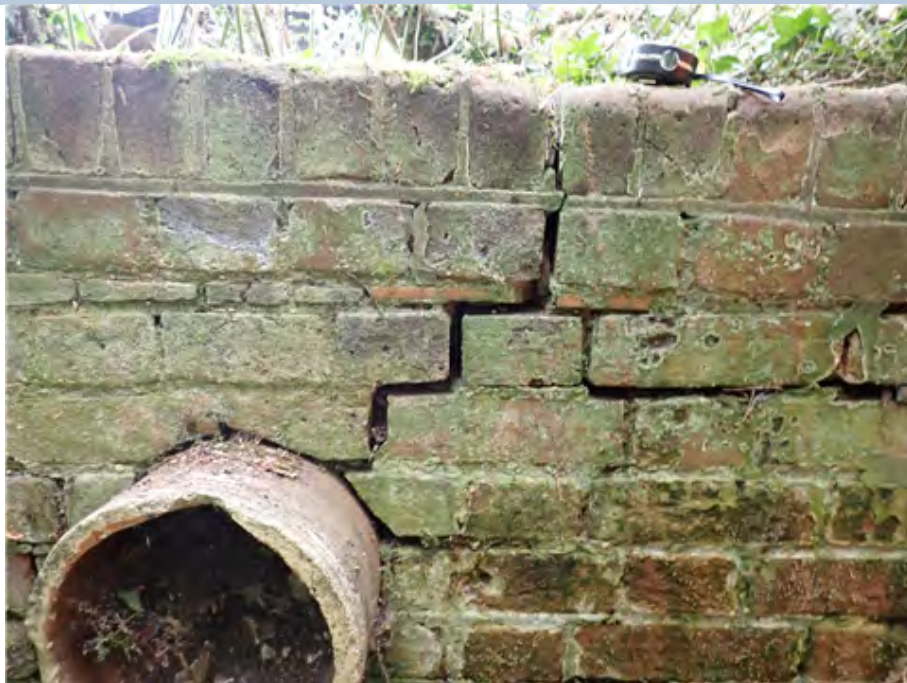
North East Wing Wall
 Stepped crack open 15mm, extending from near top of the wall to the top of the redundant drainage outlet.

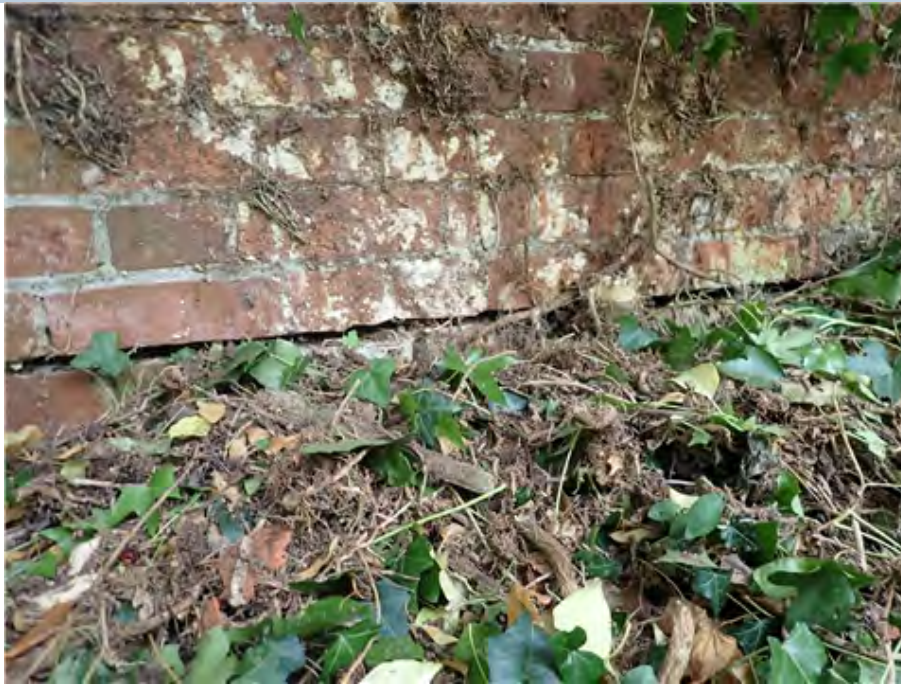
South East Wing Wall

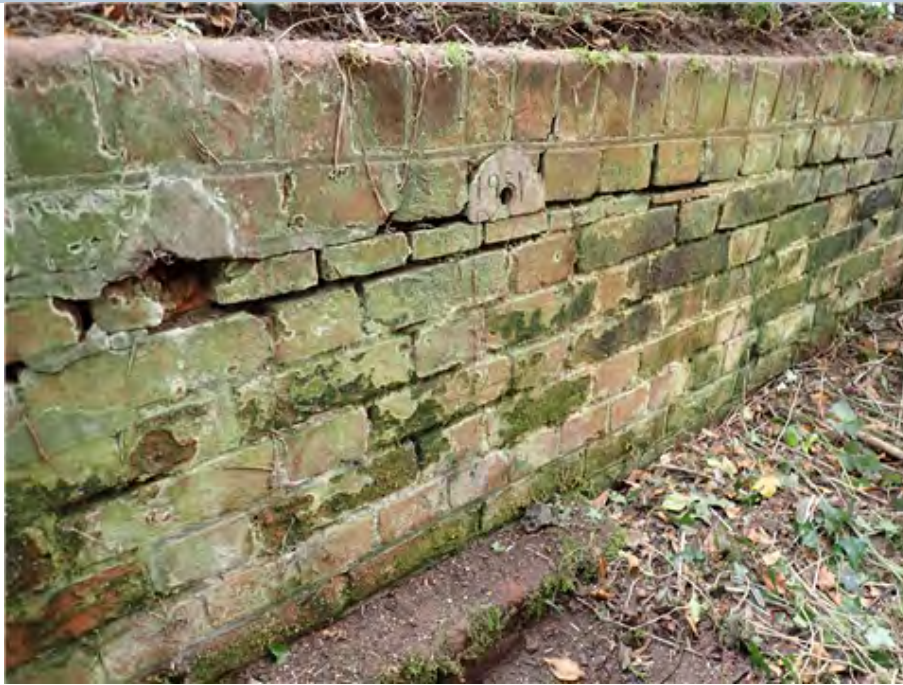
North East Wing Wall
Pointing loss to upper section between bricks to a maximum depth of 20mm.

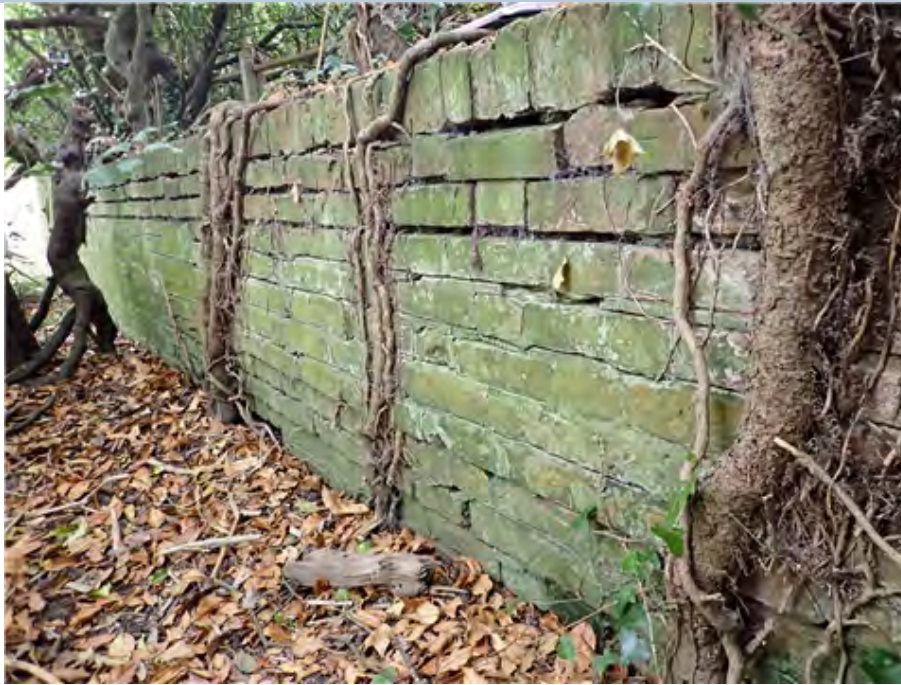
South West Wing Wall (west end, looking east)
 Roots growing up against wing wall at 1m - 10m in from the west.

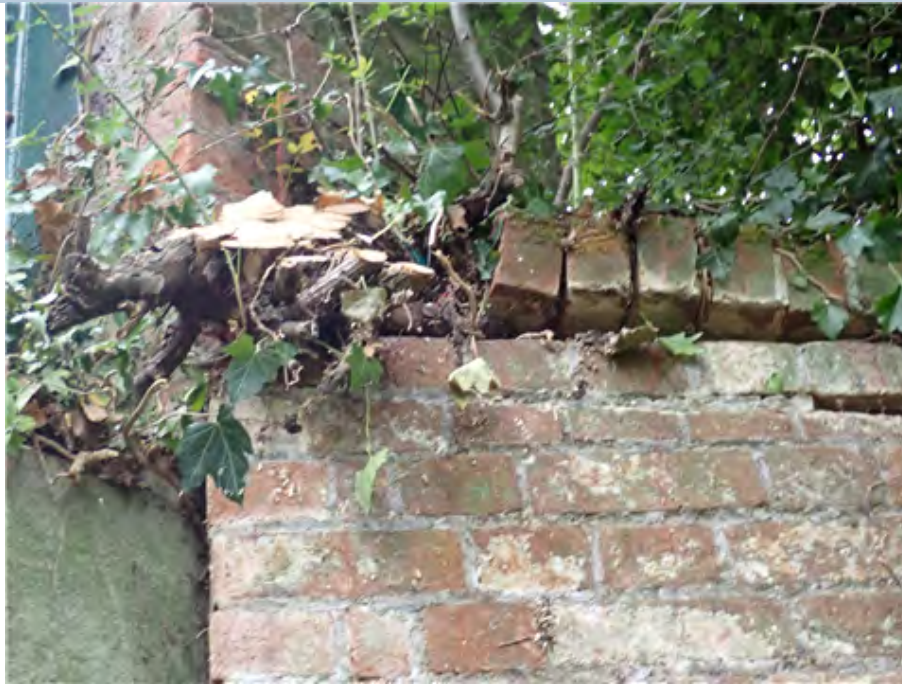
South West Wing Wall (east end)
 Tree root has pushed approximately 3no bricks off of top course.

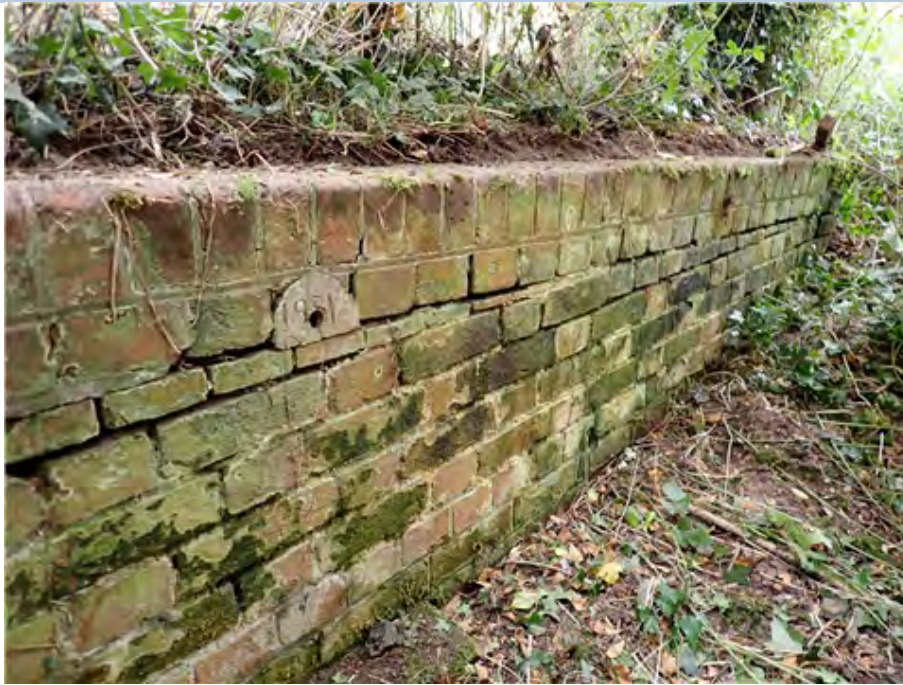
North East Wing Wall
 Moss growing on brick surface.

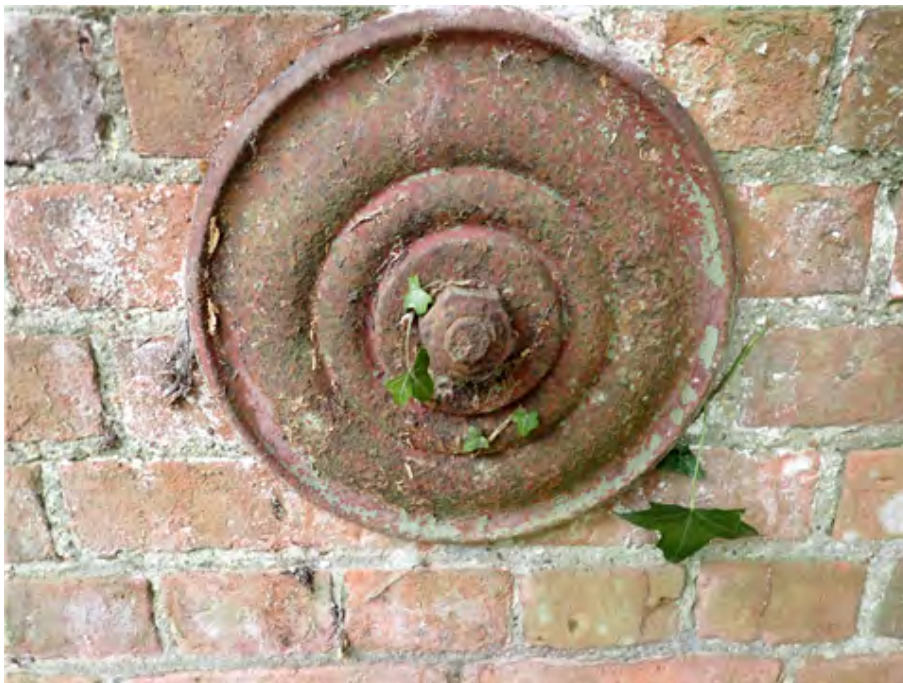
South West Wing Wall (east end)
 Pattress plates and tie rods are heavily corroded.
