Principal Inspection Report

Report Sections

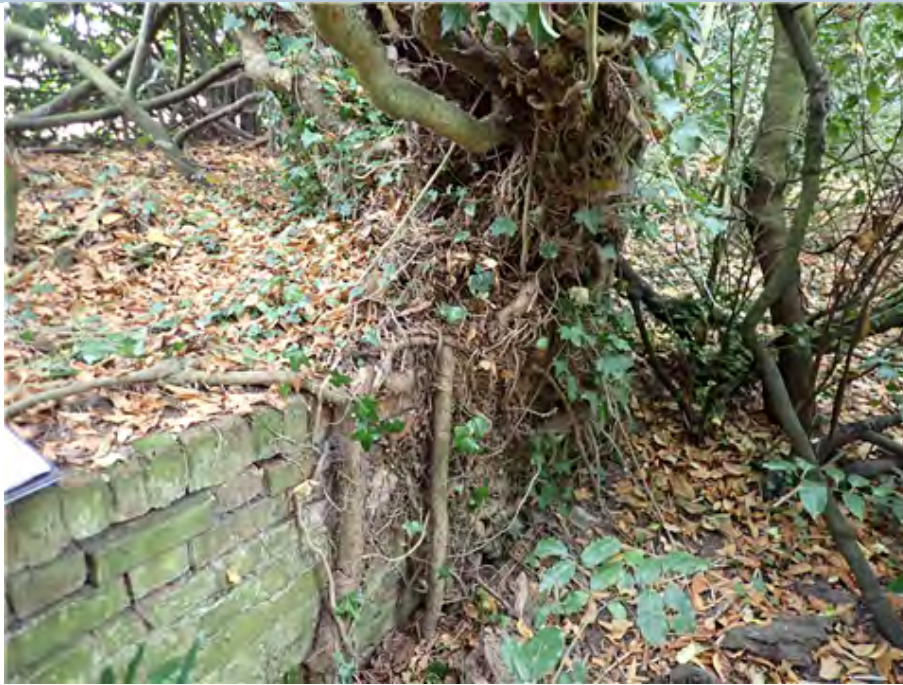
South West Embankment (west end, looking west)

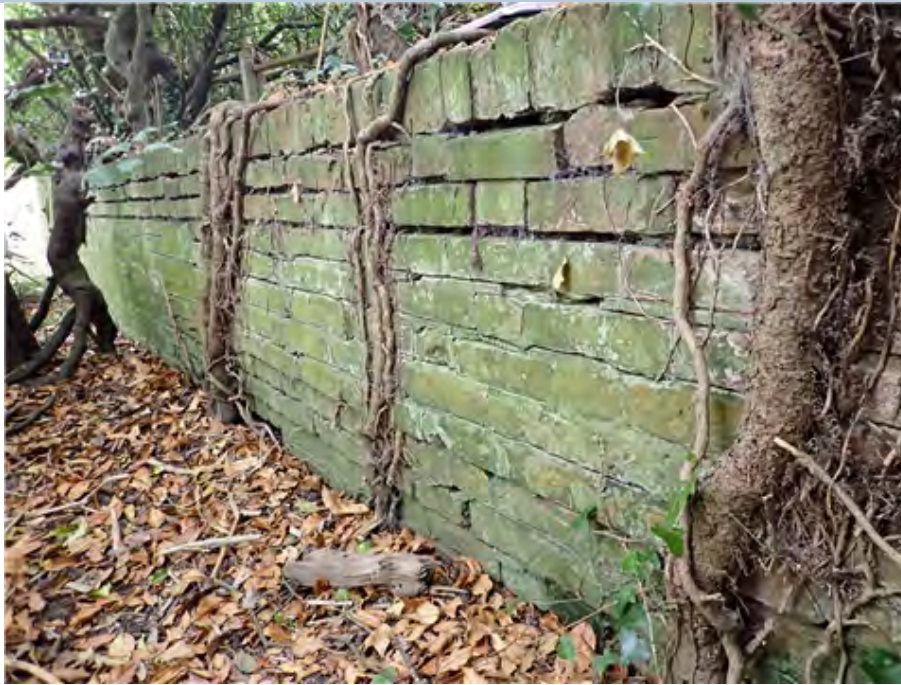
South West Embankment (west end, looking east)
 Tree roots growing on wing wall and embankment.

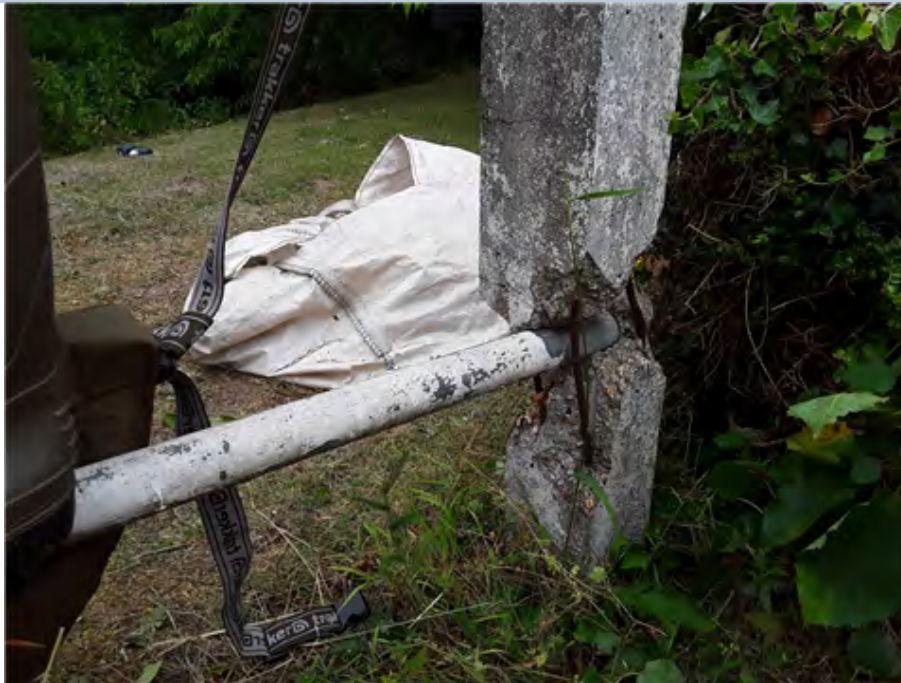
South East Approach Rail
 Concrete post broken at lower rail joint being held together by reinforcement.

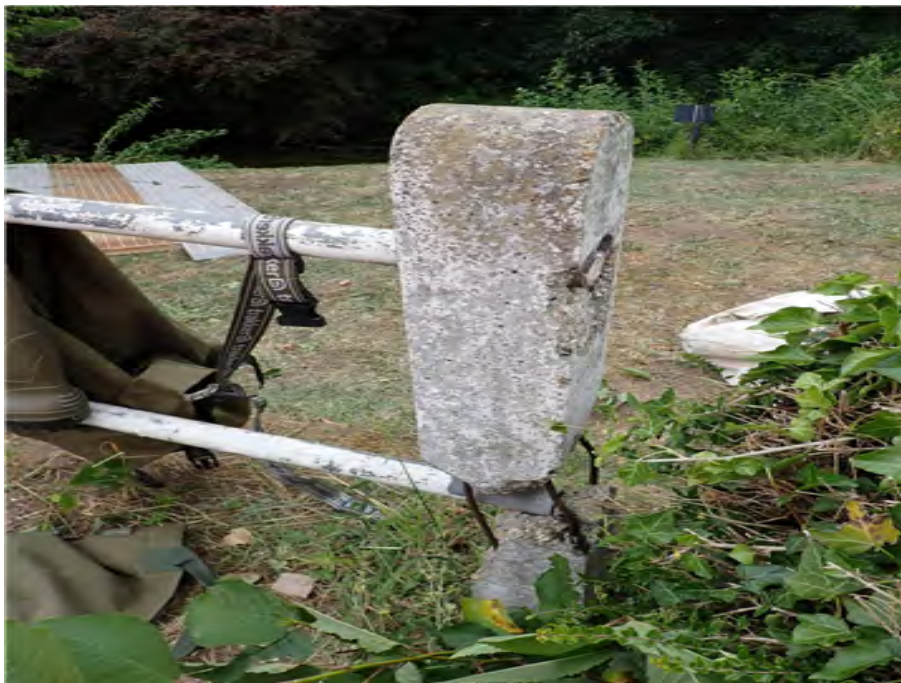
South East Approach Rail
 Concrete post broken at lower rail joint being held together by reinforcement. D end cap missing.

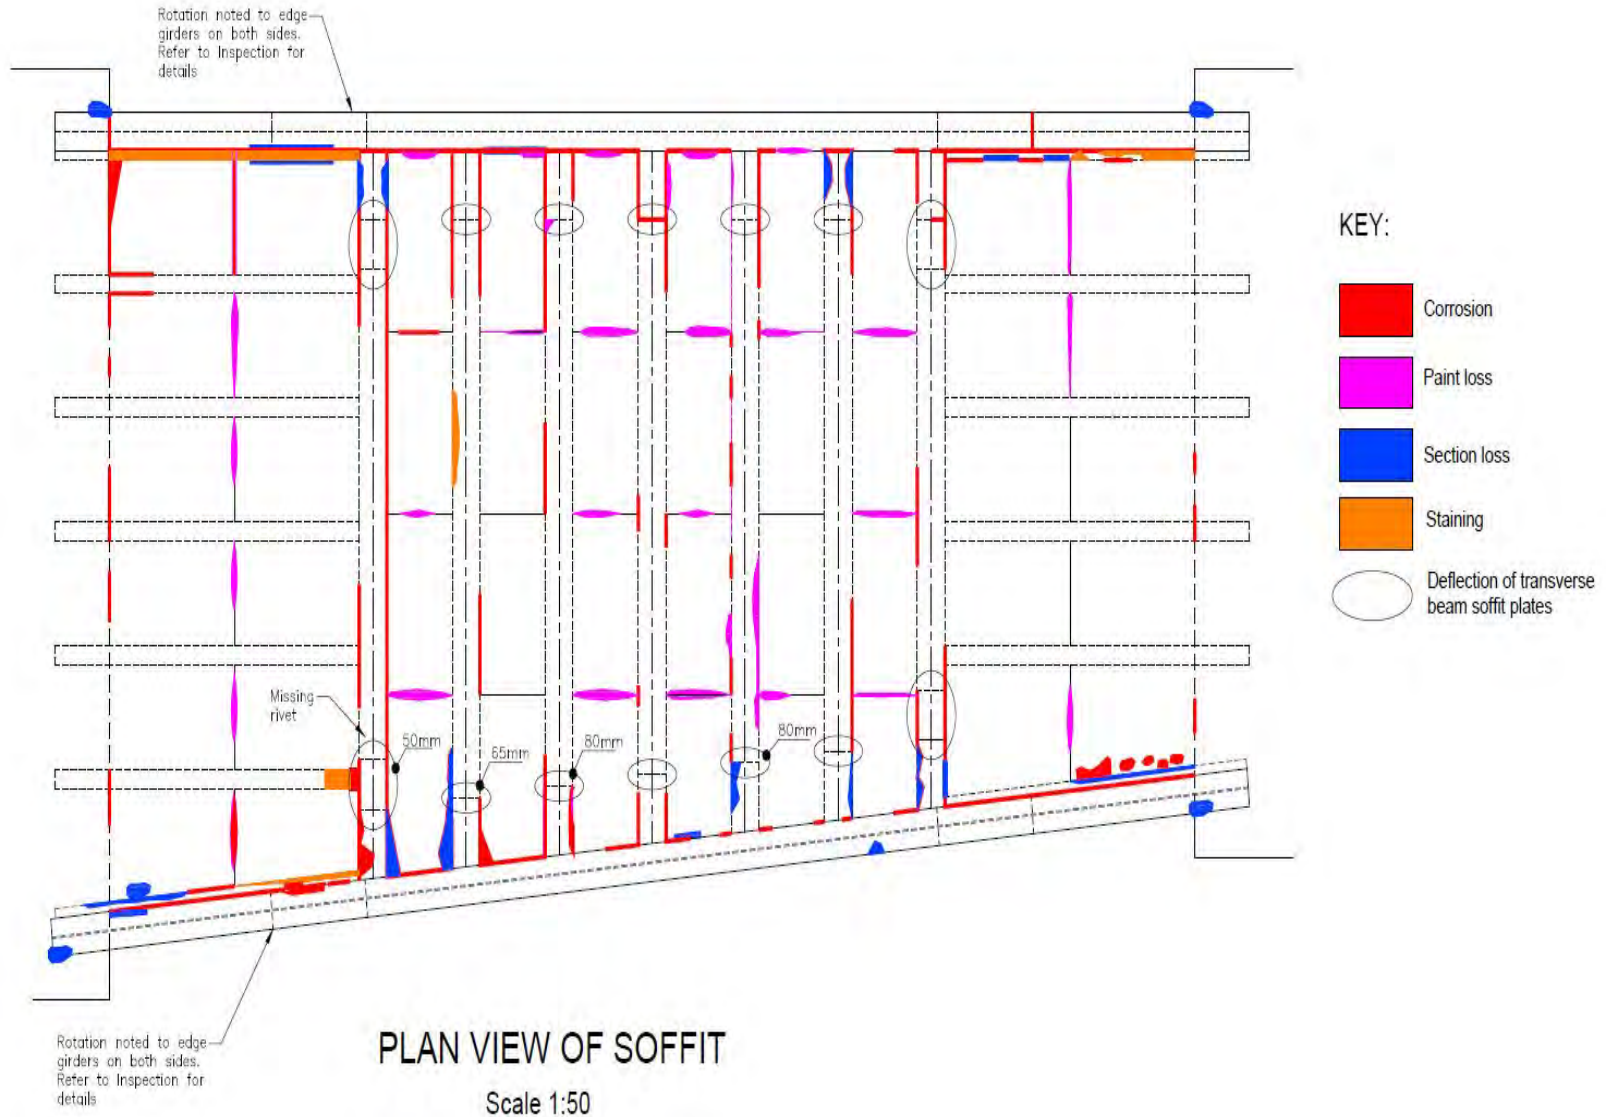
Defect Location Plans
