Boxted Bridge - Summary of considerations to date

Option study considerations

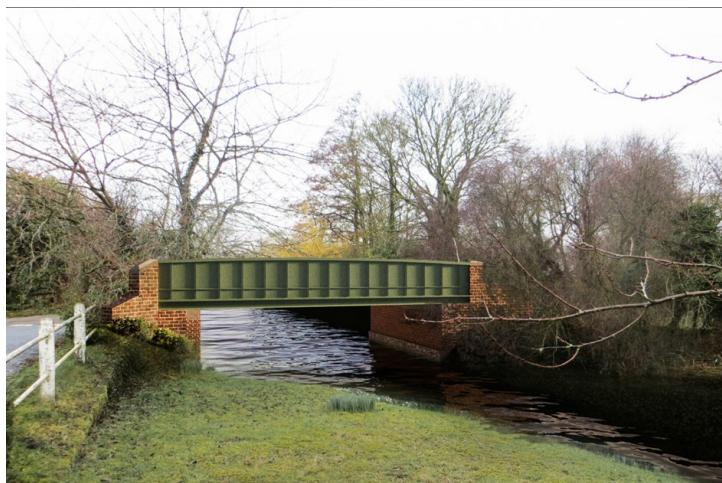
Above - Image 1 Computer generated artist impression of proposed bridge design
Below – Image 2 Existing structure

A computer-generated artist impression of how we envisage a new bridge will look is included below (image 1), which can be compared to a photograph of the existing bridge (image 2).

Boxted Bridge is in an Area of Outstanding Natural Beauty (AONB) and as such we are designing a replacement bridge to be as similar as possible to the existing bridge with as minimal change as possible to the aesthetics of the area, while improving safety for passing vehicles.
